MEMORANDUM

Subject: Task A2I2 Current Outfall Pipe Description

Report for Wairoa Waste Water Treatment Outfall

Report of Locating and Suction dredging Outfall.

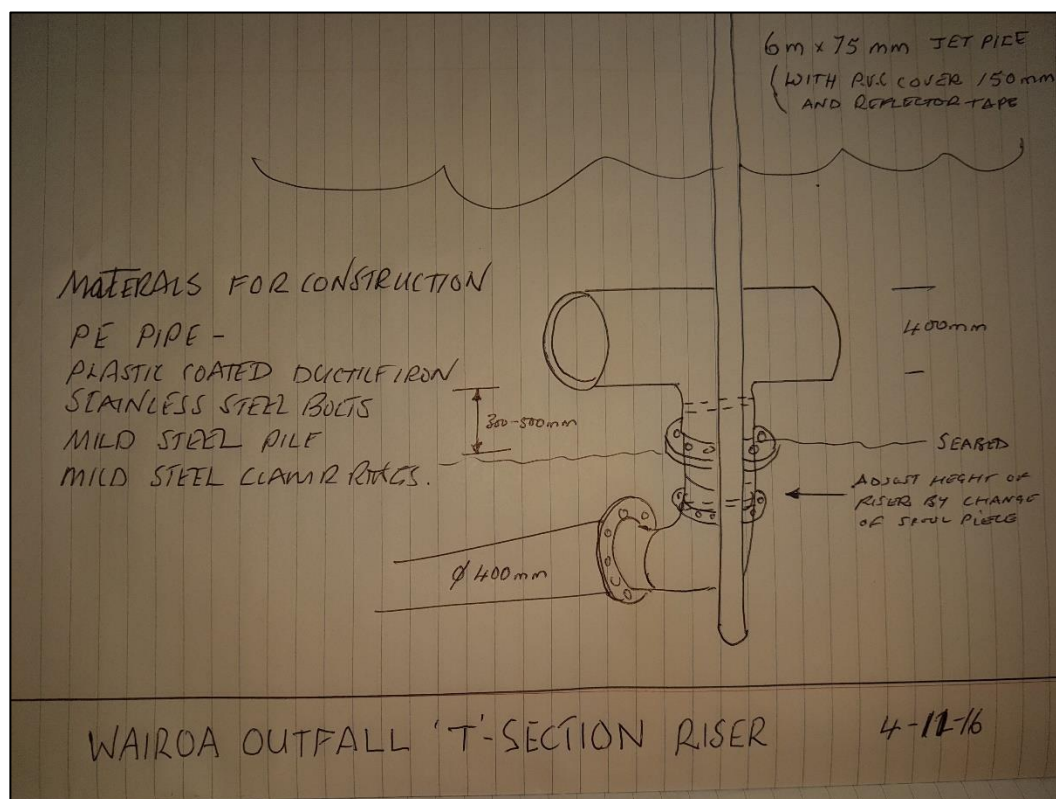
The outfall was uncovered with dredging and debris removal, but this was seen as a short-term solution with recommendations to install a stand pipe with a T junction to the current riverbed level (Figure 1), or to extend the pipeline into a deeper area of the river.

Figure 1: Description of the T-Section riser that was suggested to be installed to avoid overflows of the onshore surge chamber (source: WDC)

On 21 March 2017, a diffuser tee was installed, as per the recommendations and Figure 1 above, to prevent further issues with overflows and a backlog of discharging wastewater.

However, in April 2017 the diffuser T was removed as back pressure issues emerged. Although the diffuser T has been removed, further back pressure issues are still being experienced especially during high flows.
