Assessment of space planted native trees species for soil conservation.

Prepared for Hawke's Bay Regional Council

Prepared by Peter Manson & Erica Whalley 04 July 2024

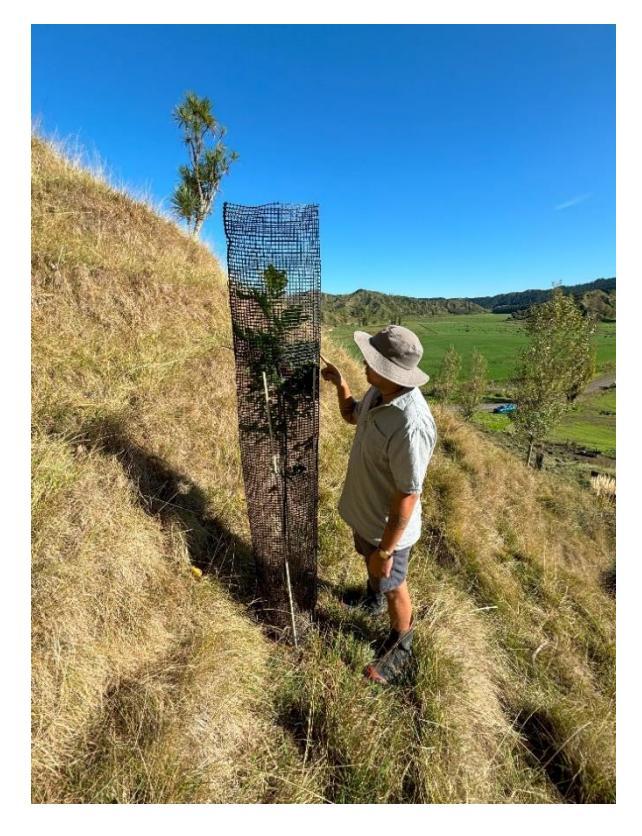
Figure 4: A 'topped up' tree guard showing the overlapped extension and 300mm extra height preventing cattle browse.

Several properties implemented extra protection for their trees. Topping up existing 1.7m high tree guards by 300mm (Figure 4) as tree seedlings reach the top, has prevented cattle and goat browse in all cases observed. Notwithstanding rubbing and crushing of the tree guard.

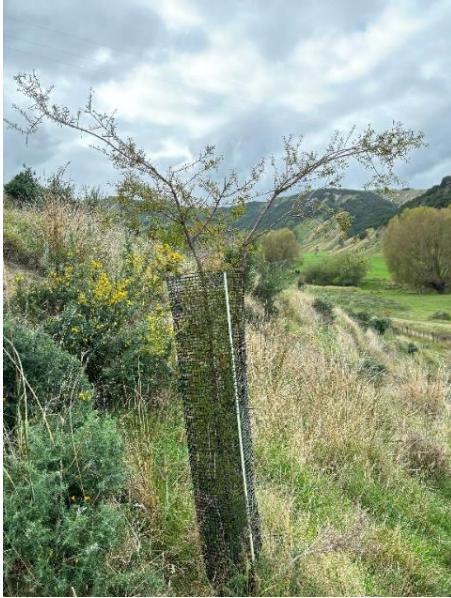
Site	Assessment				
Hereheretau Station – Whakaki (Figure 5)	<ul> <li>Known gorse issue at time of planting.</li> <li>Totara predominantly planted as resistance to Mesulfuron allowing landowner to spray gorse.</li> <li>The top of the hill slope was planted with cabbage trees and the larger area down slope was planted with totara. Grazing pressure had been low and gorse regrowth had been rapid.</li> <li>Tree guards were largely intact and totara trees were healthy in most cases.</li> </ul>				
Hereheretau Station – Hereheretau Road site (Figure 6)	<ul> <li>Fenced with a 2-wire electric fence to give better control of cattle. Unfortunately, the fence had been affected by soil slips and cattle were able to graze freely.</li> <li>Seedling losses were evident due to cattle rubbing and browsing damage but there were also examples of trees with very good growth.</li> <li>The healthiest seedlings were cabbage tree, ribbonwood, kowhai, puriri and one akeake.</li> <li>Numerous unexplained losses with tree guards still intact indicating that tree seedlings did not live long into the trial. Lack of releasing from competition with grasses etc is the most likely cause of seedling losses.</li> </ul>

Figure 5: Totara on Hereheretau Whakaki Block

The low level of cattle pressure is currently allowing good establishment and growth of Totara. However, there are two options as proposed by the farm manager; either aerial spray the gorse with metsulfuron which would likely kill the cabbage trees (Totara is resistant) or leave the gorse to grow and assume that Totara will eventually dominate the site. The second option has much more merit due to the difficulty and expense of controlling gorse long term. There are cultural and ethical reasons that this farm would prefer to encourage native tree cover where appropriate.

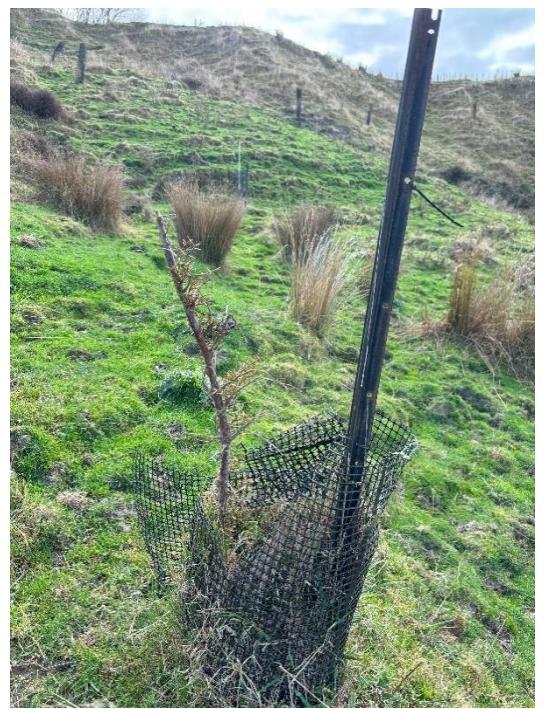
Rubbing and destruction of the tree guard is by far the most impacting of the damage types (see Figures 9 -12). This can either destroy the plant immediately in the worst case or expose it to browsing by cattle and sheep. Rubbing may topple the whole structure or break the netting open exposing the tree.

Figure 9: Destroyed tree guard exposing a small Totara to browse/rub and total loss.

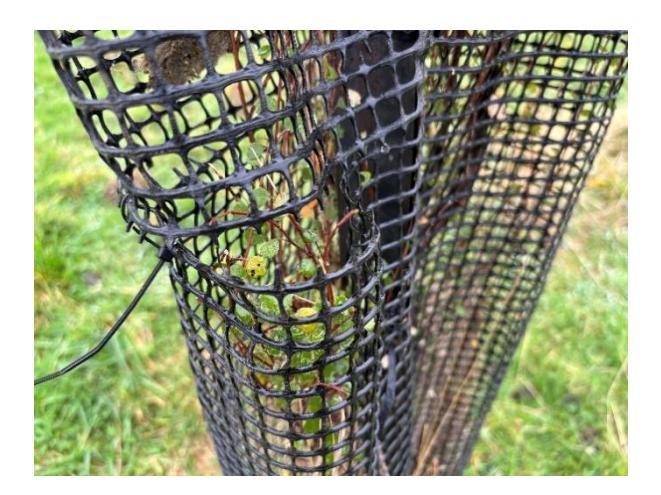
Figure 10: Slight damage from cattle rubbing. Repaired temporarily with cable ties.

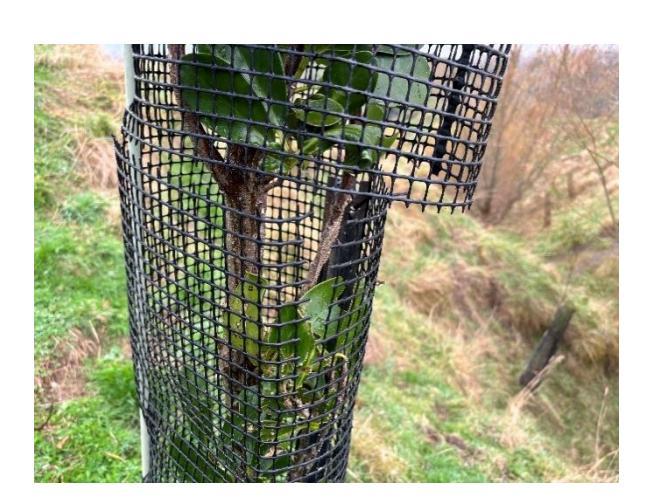
Figure 11: Damaged tree guard mesh enabling cattle and goats to browse foliage and bark.

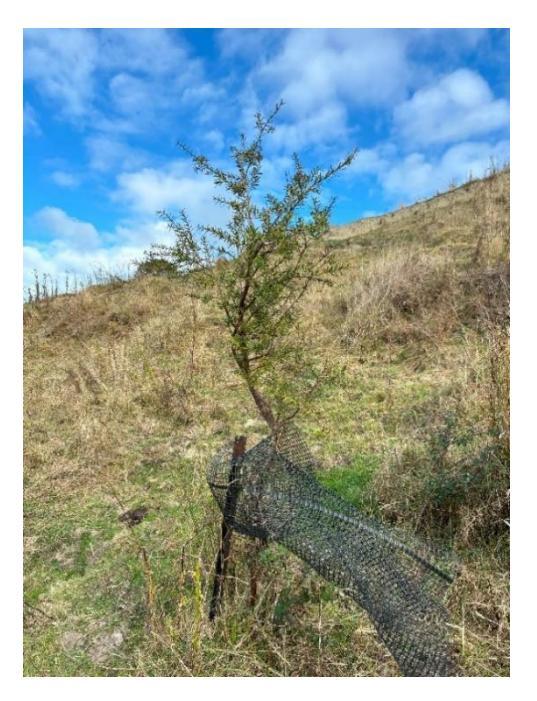
Figure 12: Destroyed tree guard, however the Totara is relatively unpalatable and may be large enough to survive.

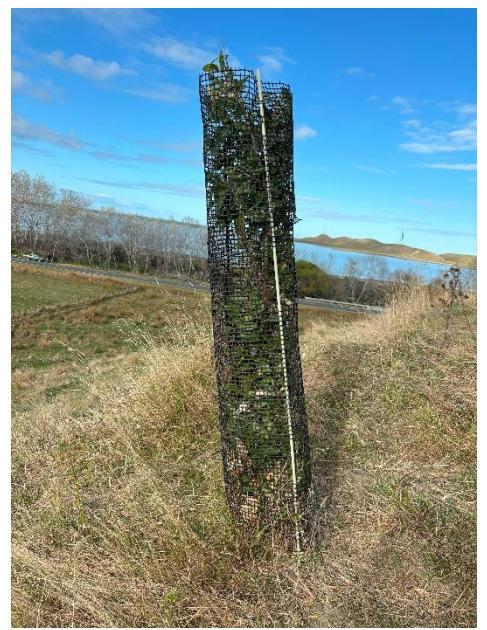
Browse at the top of the guard (Figures 13 - 16) once the tree seedling emerges, is an important but not urgent issue because the tree has reached a size that guarantees the extra investment to top up the structure and enable it to grow out of reach. However, left untended, the tree will never grow further, and it is likely that the guard and tree will be pushed over at some stage and the tree will be lost. Conversely, trees established on the two sites with almost no cattle pressure, appeared to grow fast in diameter as well as height, giving the impression that branch growth aided overall tree health and rate of establishment (Figures 17 & 18).

Figure 13: Pohutukawa browsed as it emerged from the tree guard.

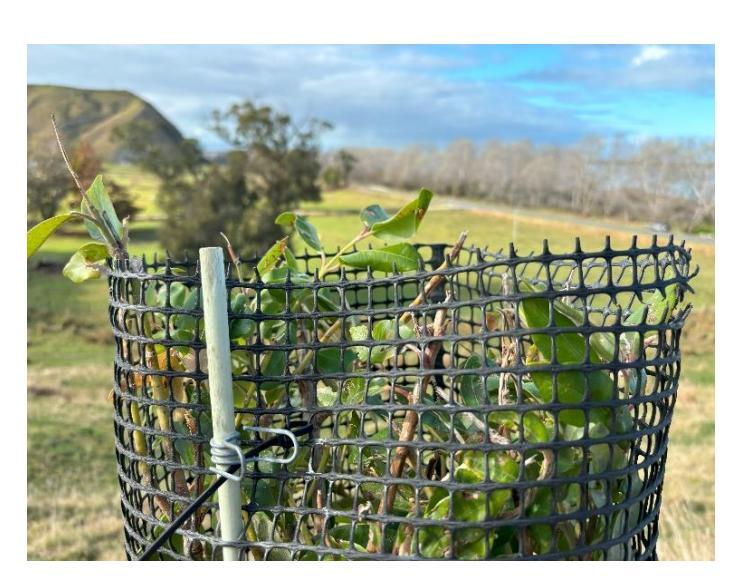
Figure 14: The same tree with browse damage evident.

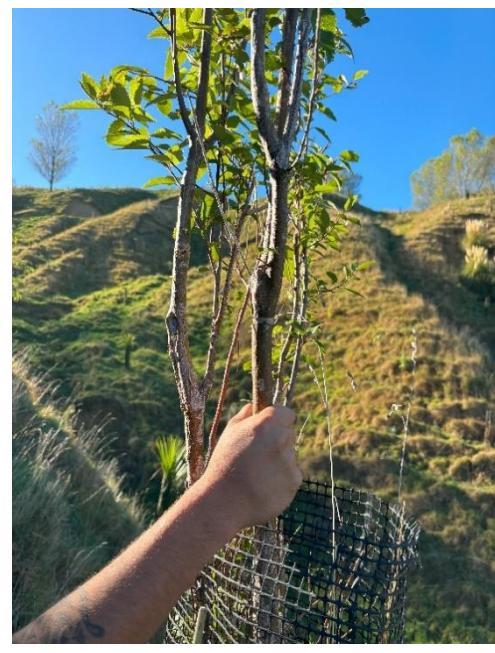
Figure 15: Lacebark with bark damage from cattle or goat browse. Not all species have palatable bark.

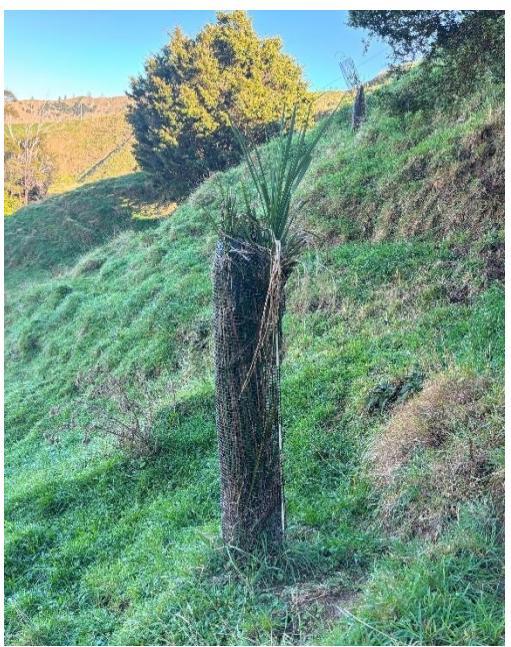
Figure 16: Cabbage tree browsed by cattle. One of the most targeted native species.

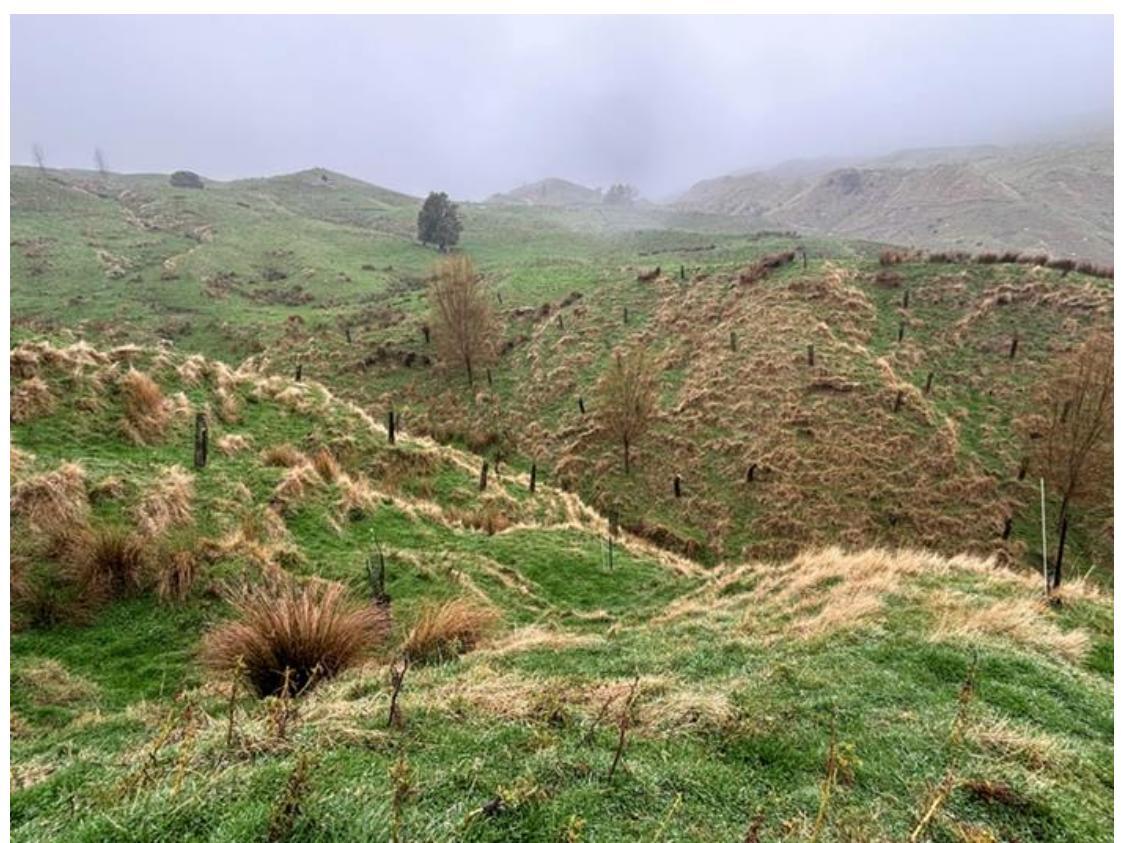
Observations on several sites that there were many tree guards in good condition, but trees were absent (Figure 19). The obvious reason seemed to be lack of control from competing vegetation (grass etc). However, the superior growth of trees on the two properties where cattle damage had been largely prevented despite vigorous competing vegetation, indicates that cattle (and possibly goats) have significantly more impact on tree growth. Nevertheless, weed control (releasing) during establishment is well understood as a limiting factor and is more important than realised by most tree growers. Competition from other plants is especially tough on new seedlings and can affect them for 1-2 years.

Figure 19: Entire tree guards with little cattle damage but few surviving trees indicating early survival issues, likely to be weed /grass competition
