Langridge, R.M.; Villamor, P.; 2011. The A7 Makaroro River dam site. Phase 1: Initial site evaluation for active deformation, *GNS Science Consultancy Report 2011/117* 35 p.

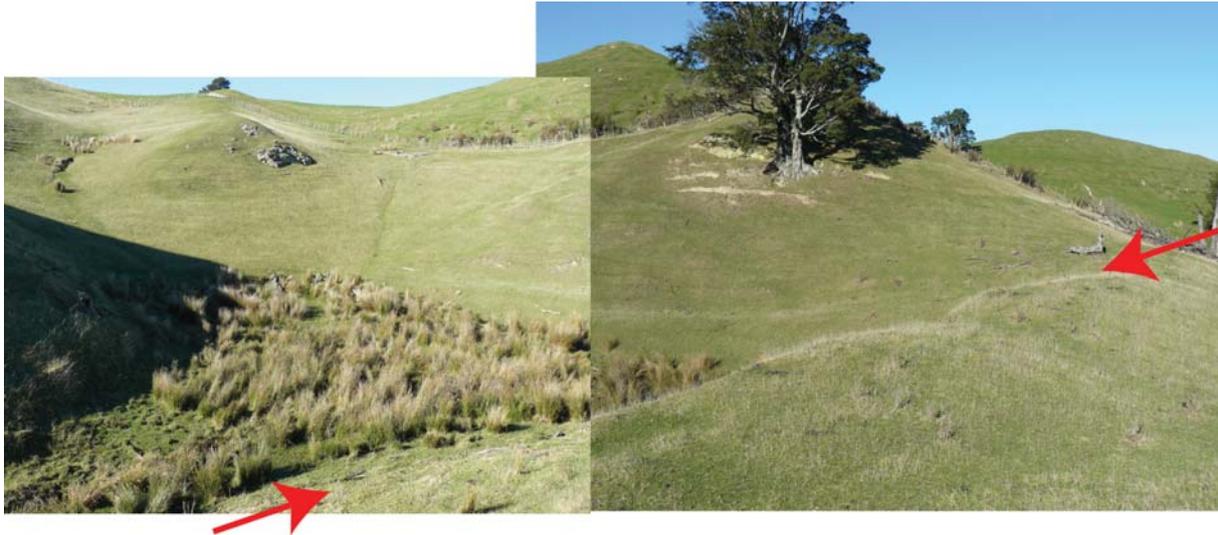
The Mohaka Fault is well-expressed on LiDAR and aerial photographs within ± 10 km of the A7 damsite. It is typically expressed by a clear, straight to slightly sinuous fault trace between Alder Road, near the Hinerua Thrust and Mangleton Road within the Gwavas forest. The fault can be mapped crossing hillslopes and alluvial terraces. In detail, the fault is often identified by an uphill-facing scarp that causes ponding to occur along the fault trace. Displaced streams are common along the fault trace. Many of the larger hillslope streams show total dextral displacements of 30-40 m (Beanland 1995; Fig. 6), indicating that there have been repeated movements along the fault during the late Pleistocene to Holocene (~ last 20kyr). During our field reconnaissance we located one site on Rangimarie Station which may indicate repeated dextral displacements of c. 4 m per event (NZMS 260 U22/899544).

Figure 6 Uphill-facing scarp of the Mohaka Fault on Rangimarie Station, marked by red arrows. At this locality a ponded basin has formed behind the scarp and the original drainage has been displaced from its source by 30-40 m and the scarp matches to the offset ridge with a large tree. Rounded to conical hillocks of greywacke occur on the east (far) side of the fault trace.

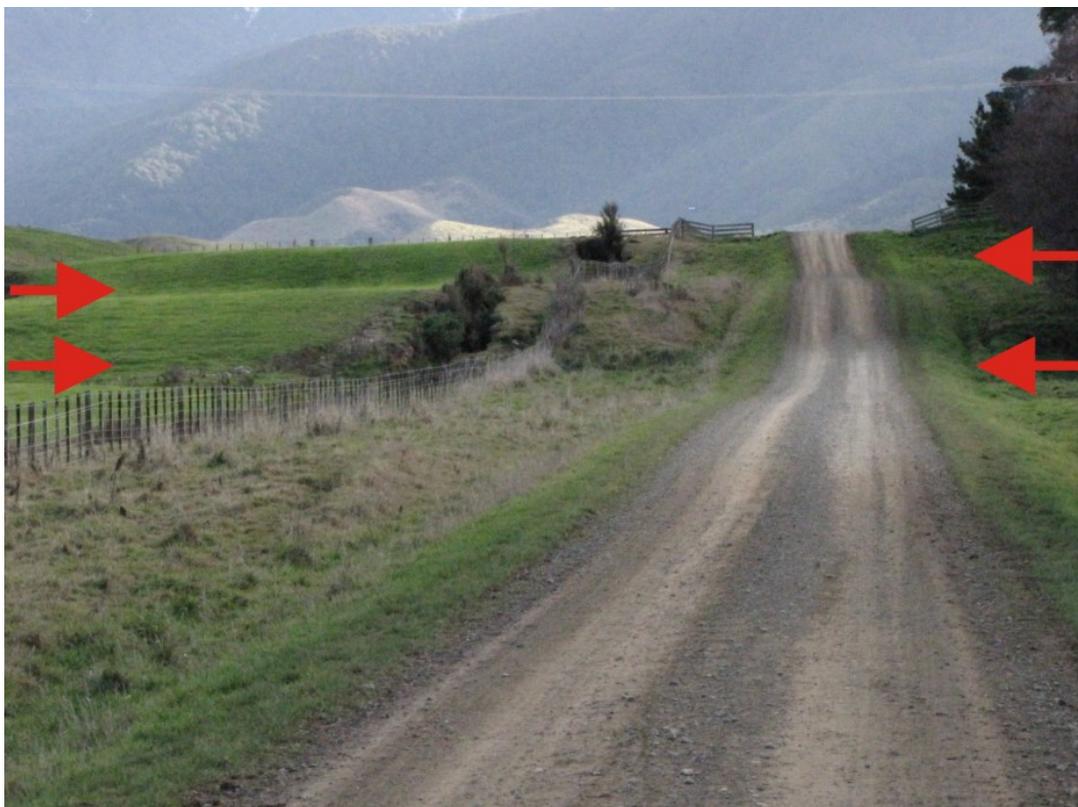
Figure 7 Pair of fault scarps of the active Rangefront Fault across Tukituki Road near the Ruahine Ranges (background). Here the fault is expressed across a probable Q2 or Ohakean ($\sim 15 \pm 3$ kyr old) alluvial terrace.

Based on the height of fault scarps, and the age of the Q2 alluvial aggradation surface (15 ± 3 kyr), it is possible to estimate the vertical slip rate of both the Rangefront and Wakarara faults. At the Tukituki Road site, the Rangefront Fault has a double scarp with an overall height of 4 m (Fig. 7). A broad, 2 m high scarp occurs at the Wakarara Road site at the northern end of the Rangefront Fault. These yield vertical slip rates in the range of 0.2-0.33 mm/yr, and 0.1-0.2 mm/yr, respectively for the Rangefront Fault. Scarps of up to 2 m in height along the Wakarara Fault are consistent with the lower slip rate for the Rangefront Fault.

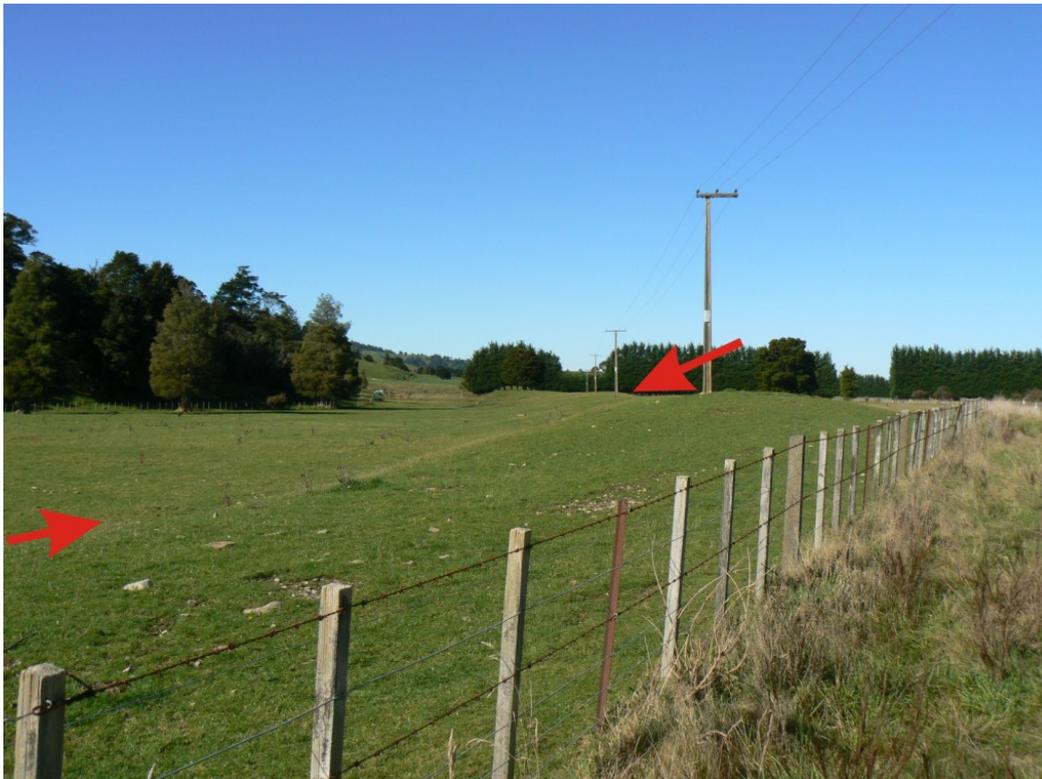
From our preliminary field reconnaissance, we suspect that the Mangataura fault has a sinistral (left-lateral) sense of movement. Geomorphically, the fault is defined by a broad (5-10 m wide and 2-4 m high) linear zone of deformation exhibited across a probable Ohakean alluvial surface (Fig. 8). Near its southeastern end, the fault crosses younger terraces of the Makaroro River, where the vertical height of the scarp is smaller. The sense of motion on this fault is difficult to assess, but near its southeastern end, we identified a potential left separation in a young terrace riser. In addition, the straight to sinuous bulged trace of this feature appears to indicate a strike-slip sense of motion.

Figure 8 View to the southeast along the scarp of the Mangataura Fault from Wakarara Road. The fault is characterised by a series of high, stepping mound-like traces up to 2 m high and 10 m wide across a probable Q2 surface. Greywacke slopes of the Wakarara Block are just visible at left.

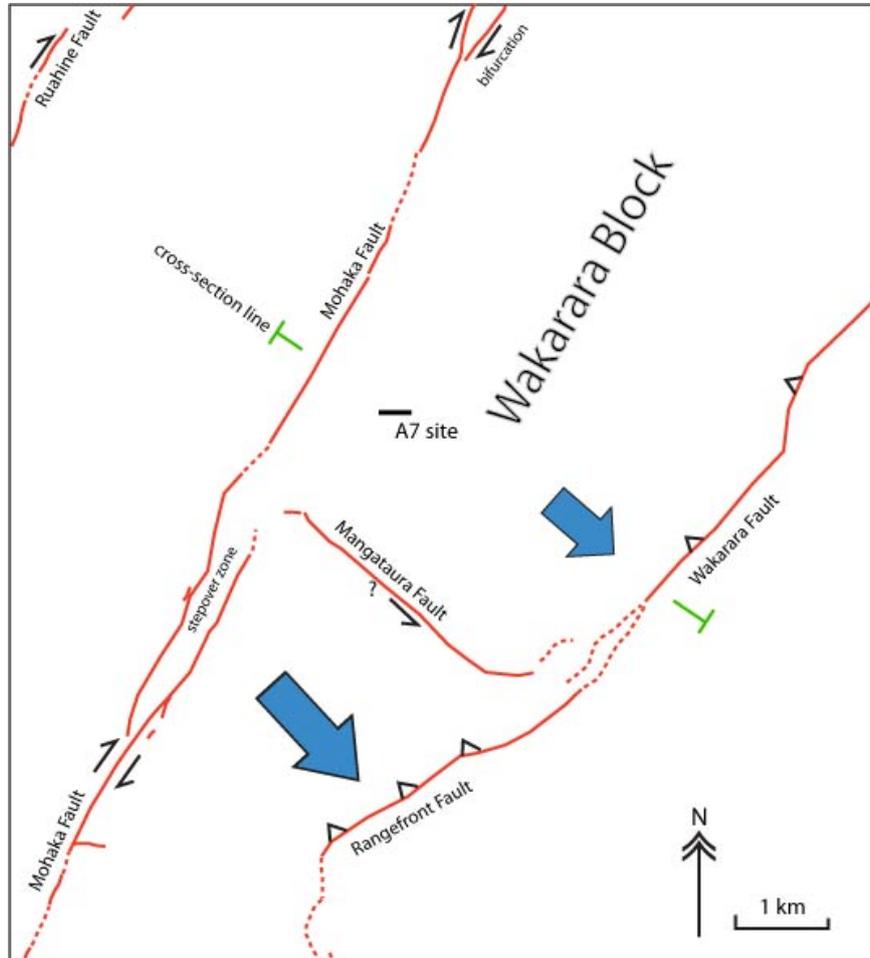
The proposed A7 dams site on the Makaroro River is located between three active faults and within the actively deforming Wakarara tectonic block (Fig. 9). The Wakarara Block is a 4-5 km wide area of greywacke bedrock bounded by the Mohaka, Wakarara and Mangataura faults. These faults have right-lateral, reverse and possible left-lateral movement, respectively.

Figure 9 Simplified kinematic model involving the key active faults within 5 km of the proposed A7 dams site. The dextral-slip Mohaka Fault is both the closest and most active fault to the A7 dams site. The Mangataura Fault is interpreted as a left-lateral (sinistral) fault. The sinistral motion (single black arrow along the Mangataura Fault) is explained if the Rangefront Fault is more active than the Wakarara Fault, which will cause faster SSE movement of the southern side Mangataura Fault compared with movement of the northern side (shown by relative size of blue arrows).

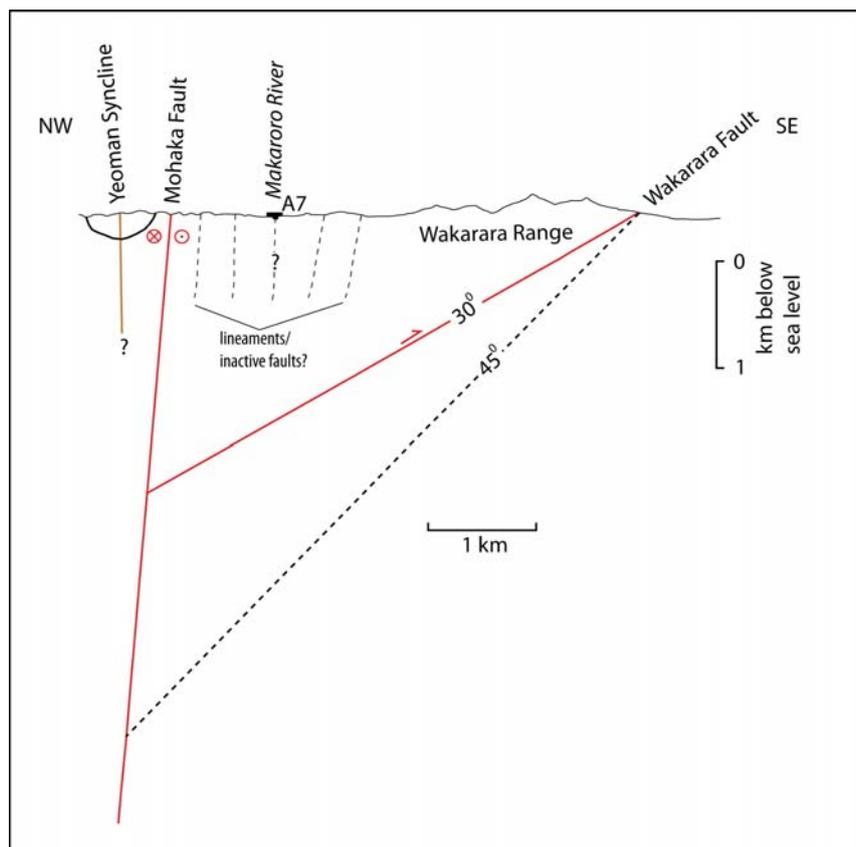
Two variations for the possible dip of the Wakarara Fault have been used to assess the closest distance of the Wakarara fault to the dams site (Fig. 10). Assuming the fault dip does not change in depth, the Mohaka and Wakarara faults would merge at depths of c. 2.5-3.0 km (case i) or c. 4.5-5.0 km (case ii). This would imply that the Wakarara Fault is at a minimum depth of c. 1.8 km depth beneath the proposed dams site.

Figure 10 Simplified geologic cross-section running NW-SE through the proposed A7 dams site on the Makaroro River. Two models for the dip of the Wakarara Fault are shown; the first with a shallow (30°; preferred) dip (in red) and the second that has a moderate, 45° dip to the NW (in black). A series of geomorphic lineaments/valleys are marked in the vicinity of the Mohaka Fault and A7 site. Location of cross-section line is shown on Figure 9.

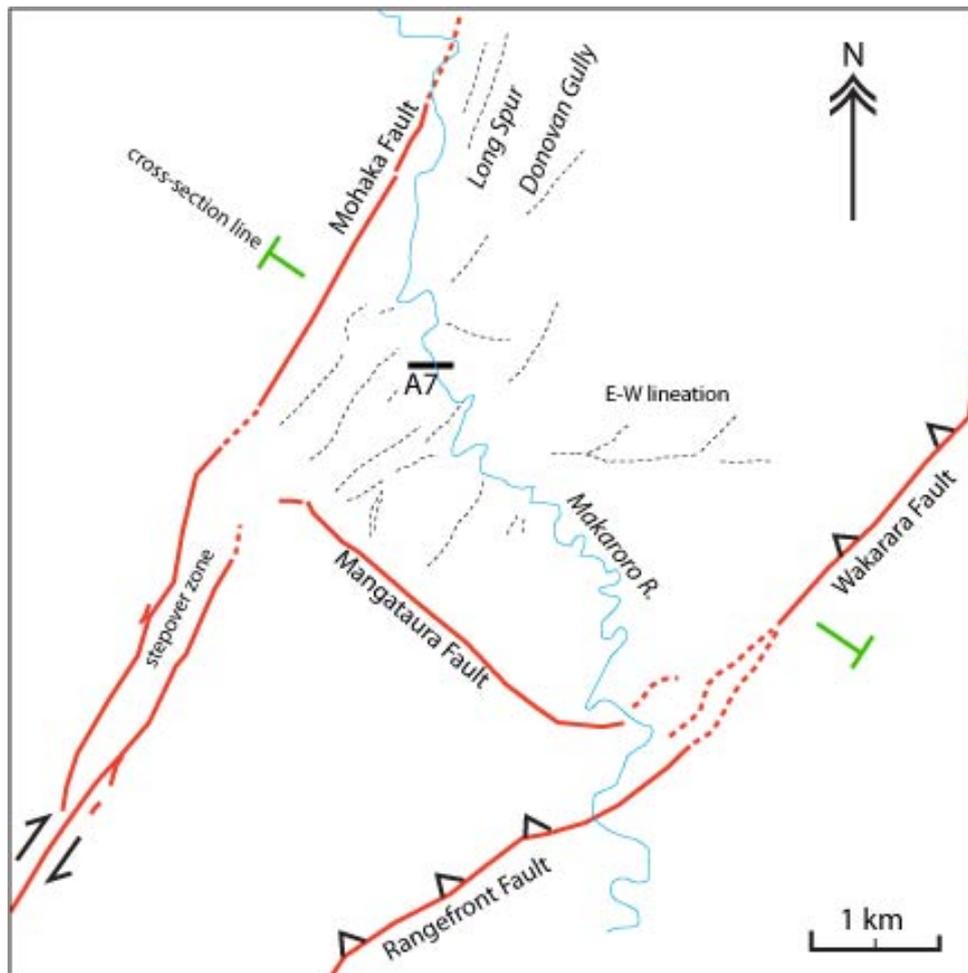
A second pattern of lineaments occurs in an E-W orientation in the southern part of the Wakarara Block. One lineament in particular is semi-continuous over a length of 1-2.5 km and typically appears to cross-cut the regional grain of NNE- to NE-trending geomorphology (just north of Makaroro River, Fig. 11).

Figure 11 Kinematic map similar to Figure 9. In this case, bedrock and geomorphic lineaments within the Wakarara Block (dashed dark grey lines) compiled and/or mapped in this study are also shown. These lineaments tend to have NNE- or E-W trends and could potentially intersect the A7 damsite

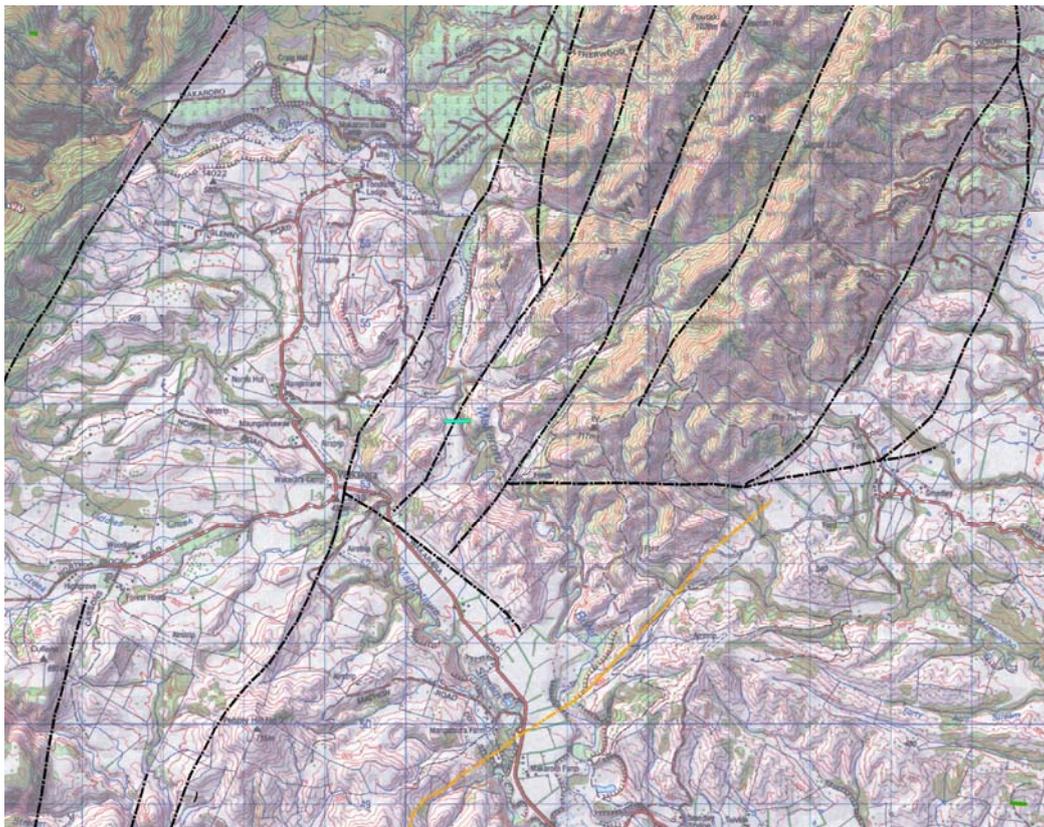
Of significant importance is the fact that one of the NNE-striking geologic faults shown by QMap as being within the Wakarara Block extends right through the foundations of the A7 damsite. This fault is shown as an inactive geologic fault that runs along the length of Donovan Gully, though the site and continues to the SSW until it meets the Mangataura fault. The relevance of this fault is not known at this time. However, it raises the question that a fault has been mapped continuously across the Q2 alluvial terrace and through the site. This will require investigation to either confirm or deny the relevance/activity of this feature.

Figure 12 Geologic faults (black dashed lines) and folds (orange dashed lines) shown on the upcoming QMap Hawke's Bay geologic sheet (Lee et al., in press). The proposed A7 dam structure is identified by a blue bar at centre. A NNE-striking bedrock fault that runs up Donovan Gully is shown intersecting the A7 damsite.

- (i) To confirm that there are no structures that have produced or have the potential to produce displacements through the dams site, we recommend that trenches be excavated in the vicinity of the proposed dams site. A wide terrace surface (probably Q2; 15 ± 3 kyr) occurs on the true right side of the valley and is in the area of the right abutment of the dam. Large trench excavations representing tens of metres in length and up to 10 m in depth are required to view the bedrock erosion surface beneath this terrace. A thorough examination of attitudes of the bedrock and potential shear planes needs to be undertaken. Such excavations should be a pre-requisite of siting the dam and should be undertaken at an early phase in the project to eliminate the possibility of significant defects in the foundation of the A7 dam, e.g., the geologic fault/lineament shown in Figure 12 (from QMap Hawke's Bay) must be investigated or further considered. If such geological structures are found, the size and recurrence of displacements should be assessed.

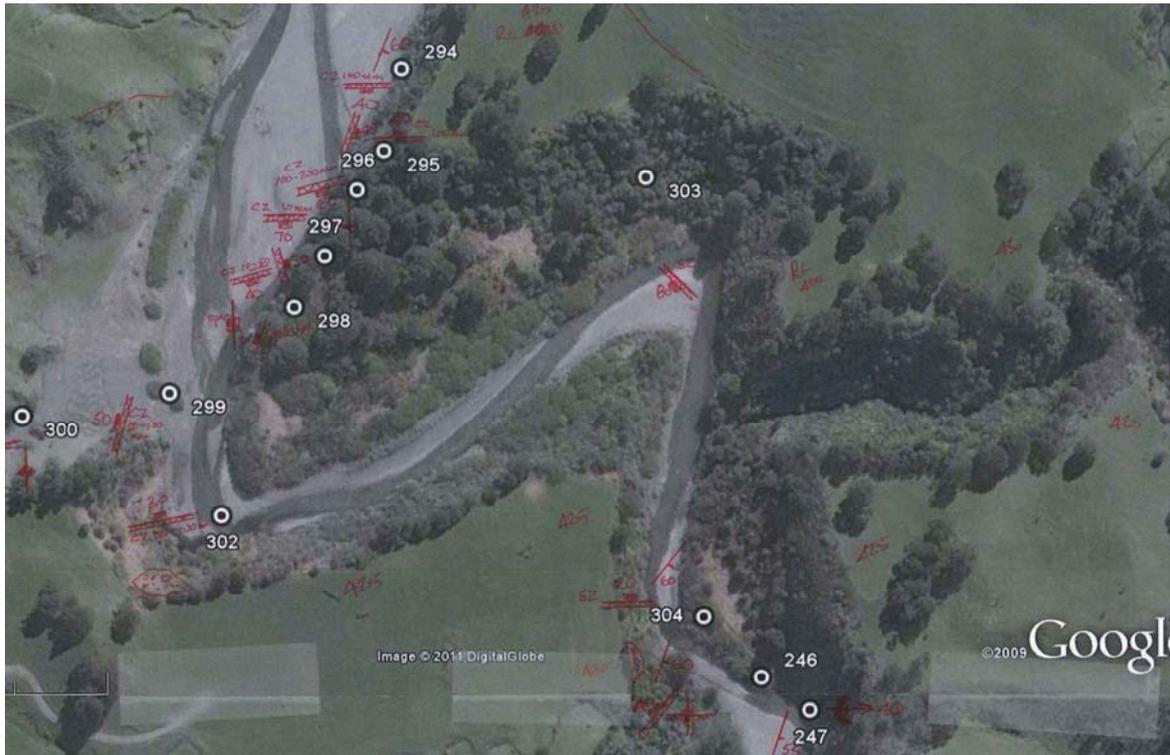
Image 2 Bedrock and shear zone attitudes immediately upstream of the A7 site

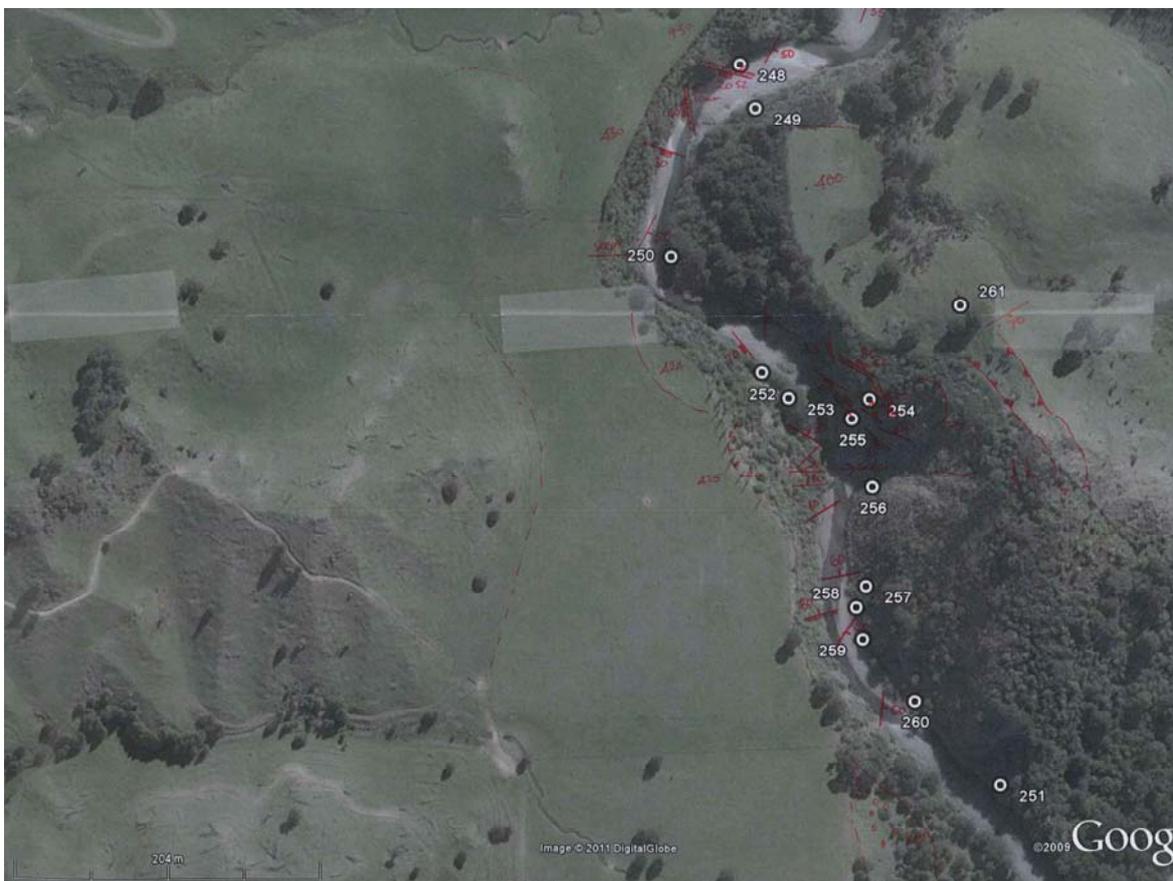
Image 3 Bedrock and shear zone attitudes in the immediate vicinity of the A7 site
