Independent Operational Review of Wairoa River Bar Management

Prepared for
Hawkes Bay
Regional Council
26 August 2024

Wairoa River Bar – Operational Review

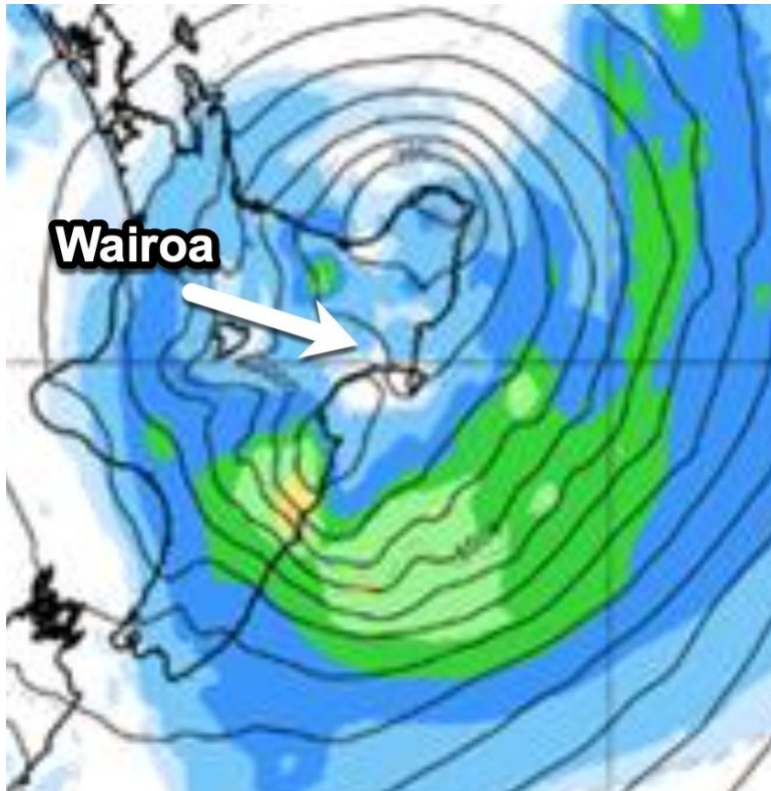
Figure 4-1 MetService Rainfall Forecast Friday 21 June 2024

On Friday 21 June rainfall was forecast for the following week for the East Coast of the North Island and was predicted to be affecting catchments to the north of Wairoa and to the south into Central Hawkes Bay but not the Wairoa catchment itself (See Figure 4-1). Very large sea swell was also forecast for this event with wave heights of up to 7 m predicted by MetService. On the basis of this information HBRC put Pryde Contracting on stand-by. I note that two of the key conditions for a mouth opening were not in place at this point, namely no rain was actually forecast for Wairoa and there was significant swell predicted. HBRC made the decision to put Pryde Contracting on stand-by on the basis that it was prudent to be ready if the forecast rainfall and swell conditions changed in the coming days.

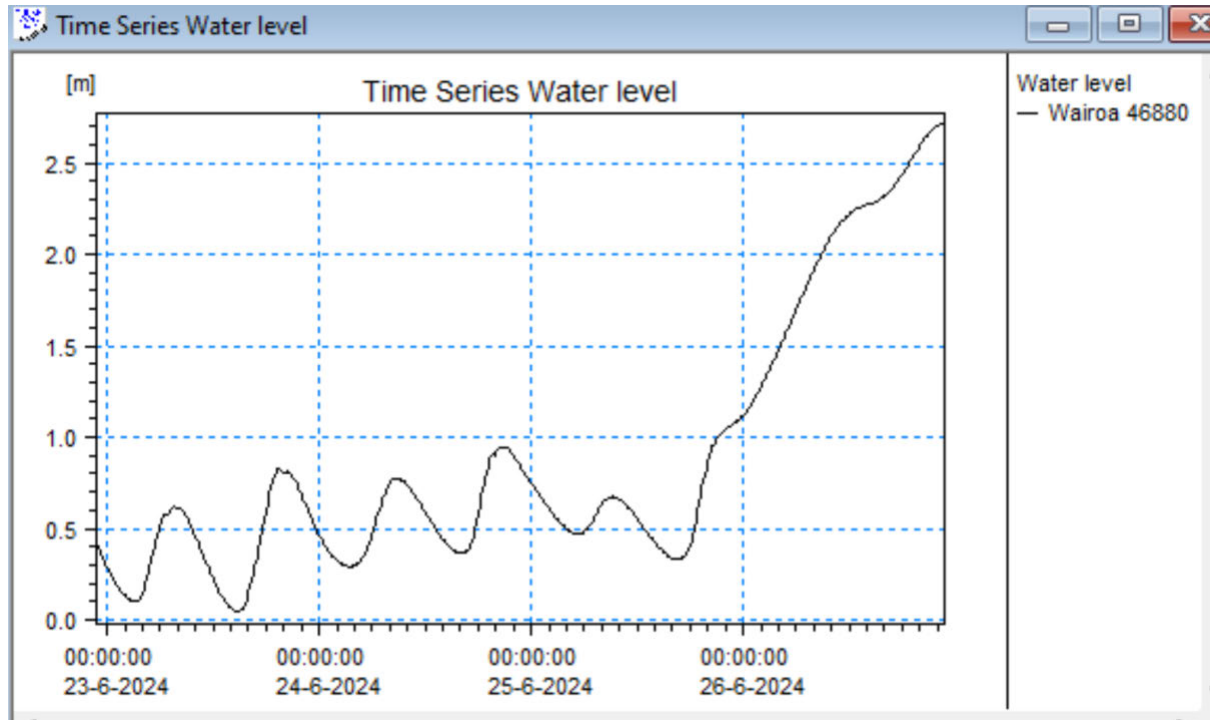
Figure 4-2 HBRC Wairoa River Level forecast 11:40pm Monday 24 June

At 11:30pm on Monday 24 June HBRC updated their flood forecast which had now increased to be more significant with a 1.7 m rise in river levels (above high tide) and importantly that rise in river levels was now starting earlier, from about 8pm on Tuesday 25 June. The forecast for 6 m swells remained unchanged. The timing of the rising river levels is most significant now as this now means that any attempted closure of the existing river mouth and cutting of a new river mouth needs to be complete by nightfall on Tuesday.

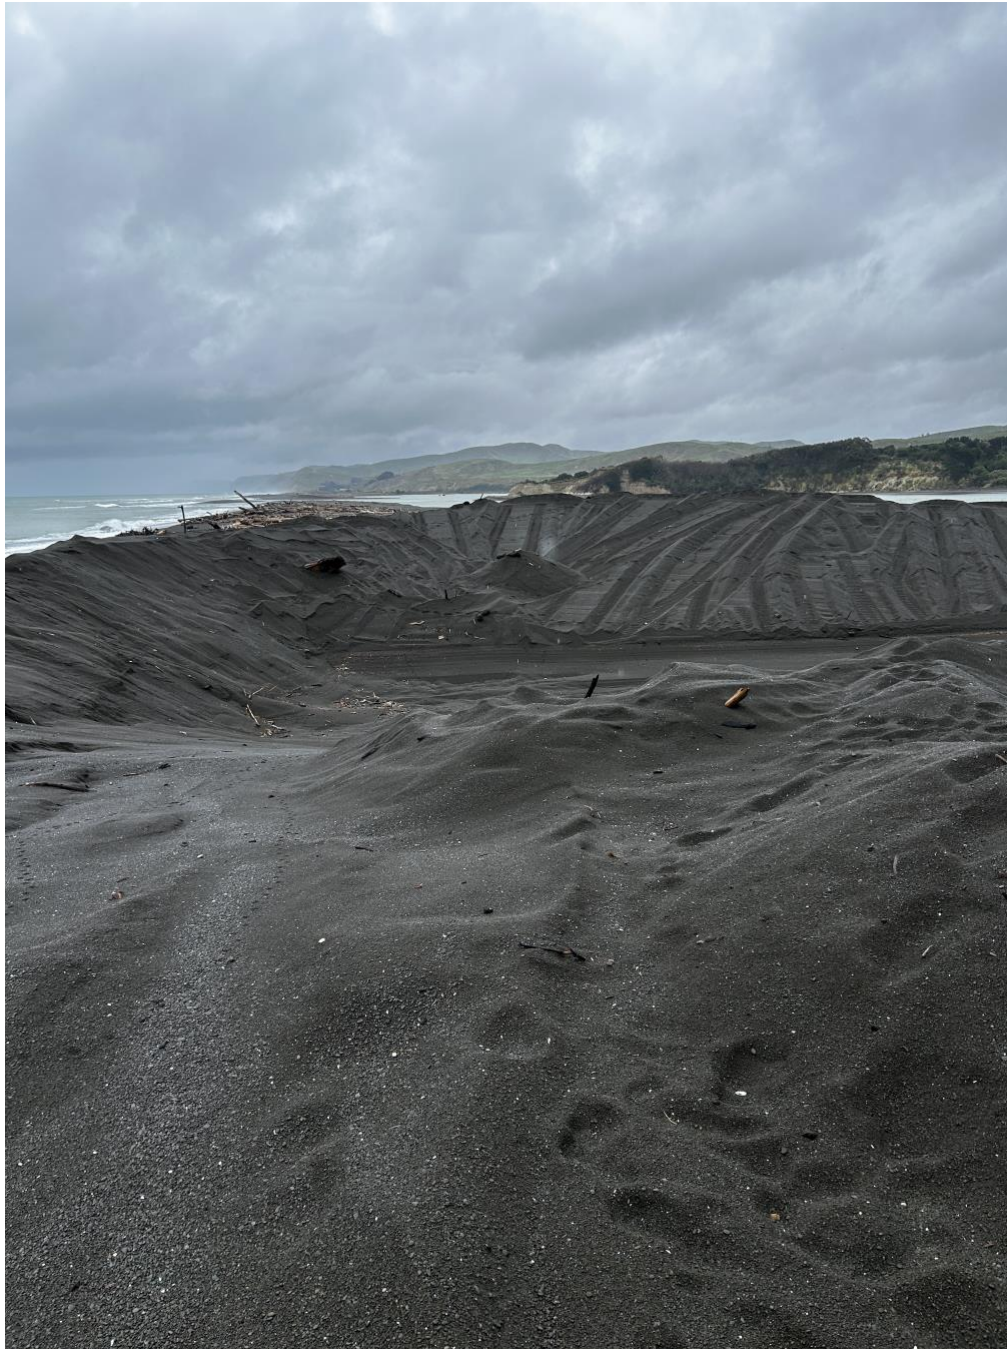
Figure 4-3 Wairoa River bar seaward coffer dam and upstream pilot channel (9 August 2024)

Notwithstanding the above, Pryde Contracting went ahead on Tuesday 25th of June on the basis of the instruction for a full mouth opening procedure from HBRC which included deploying a bulldozer at the existing river mouth to start building up sand for an attempted closure on Wednesday morning as well as cutting an upstream pilot channel down to water level at the new mouth location with a seaward coffer dam.

Pryde Contracting worked until nightfall on Tuesday 25th of June and left the site under conditions that were already extremely dangerous with high winds, heavy rainfall and large waves starting to break over the crest of the beach. Notably the seaward coffer dam was in place on the pilot channel they had partially excavated during the day. For the purposes of explanation an example of a more fully formed upstream pilot channel cut with a seaward coffer dam is shown in Figure 4-3 below. This is likely a similar general arrangement as what was in place at nightfall on Tuesday 25th of June but with the upstream channel not developed to the same extent (depth or width).

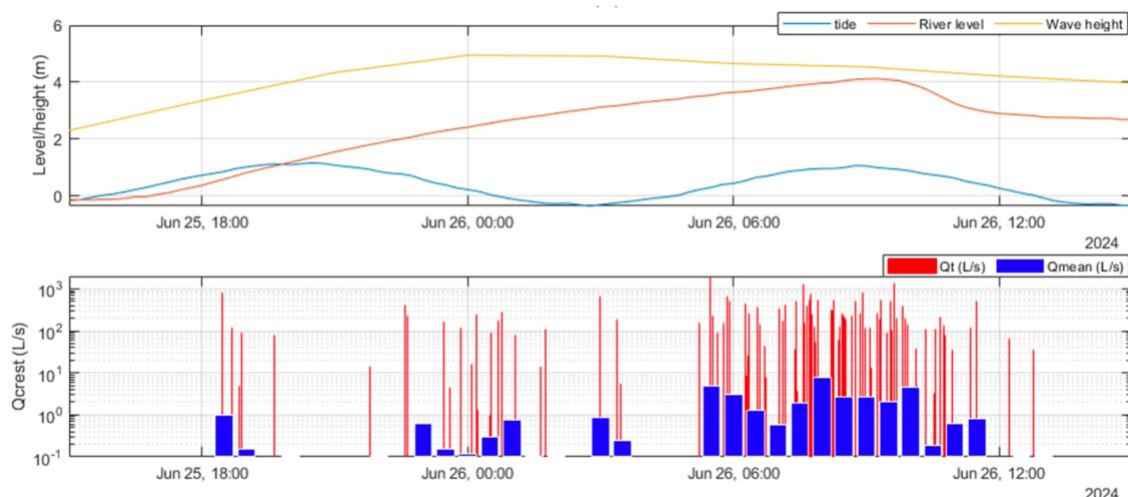
Figure 4-4 Modelled wave height and intensity of overtopping (Source T&T 2024).

The best summary of the likely wave environment over this period is shown in Figure 4-4 below which is taken from the T&T report. It is also noted in the T&T report that the modelled wave height predictions for this event could be underestimated by up to 30%.

The modelled wave heights show overtopping occurring as the wave heights increase after 6pm on Tuesday night with the rising tide which was high around 8pm. This is consistent with observations made by Pryde Contracting as they were leaving the site around this time. Further notable overtopping occurs around midnight as the wave height increases to 5 m and from around 4 am the most significant period of wave overtopping occurs with the rising tide and wave heights still around 5 m.

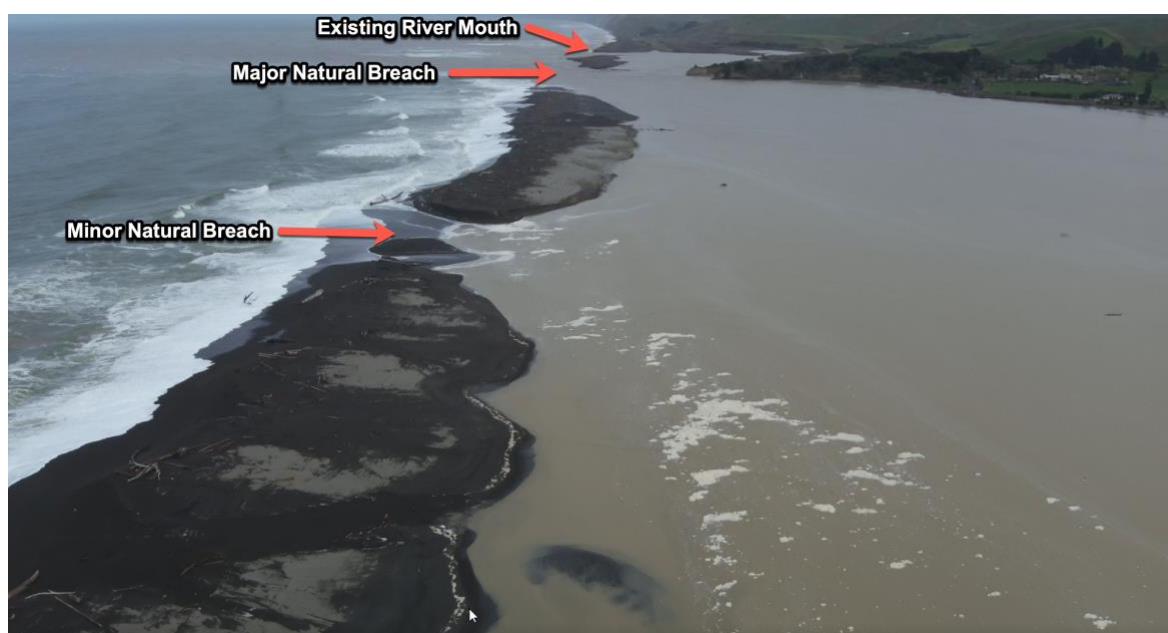
Figure 4-5 Aerial image showing the existing river mouth and natural breaches that occurred during the event (Source FENZ UAV)

after the peak of the flood the water levels rapidly drop most likely due to a large natural breach forming of approximately 120 m wide with a base level of -2.5 mRL being the same as the dimensions of the existing river mouth.

In addition to the existing river mouth and the large natural breach to its immediate east right out in front of Pilot Hill, there was another smaller natural breach further east (See Figure 1-1) but notably where Pryde Contracting had done there works there was no breach (See Figure 4-6). This was at least in part due the natural height of the surrounding beach crest as well as the seaward coffer dam that was in place.

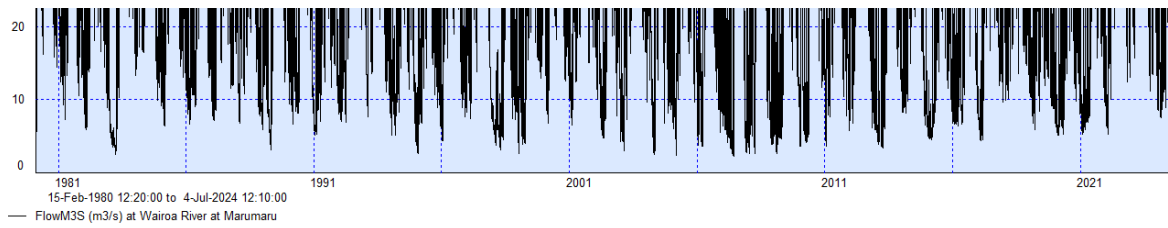
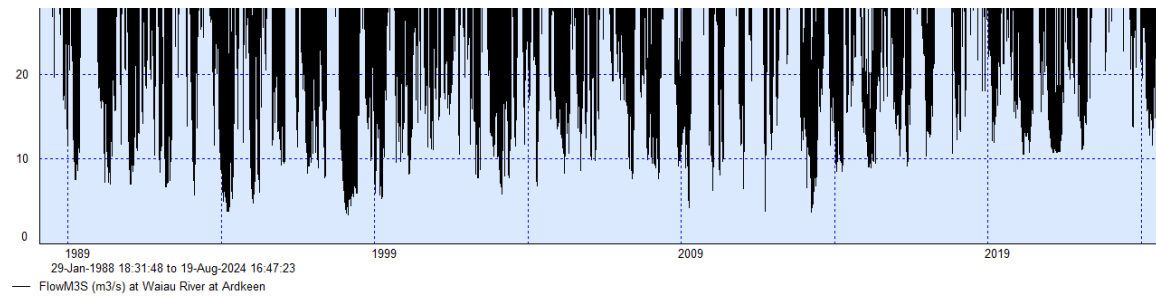
Flow hydrographs from Marumaru and Ardkeen (shown below) indicate minimum flows are in the order of 5 m³/s from Waiau and 10 m³/s from Wairoa, giving a total of around 15 m³/s.

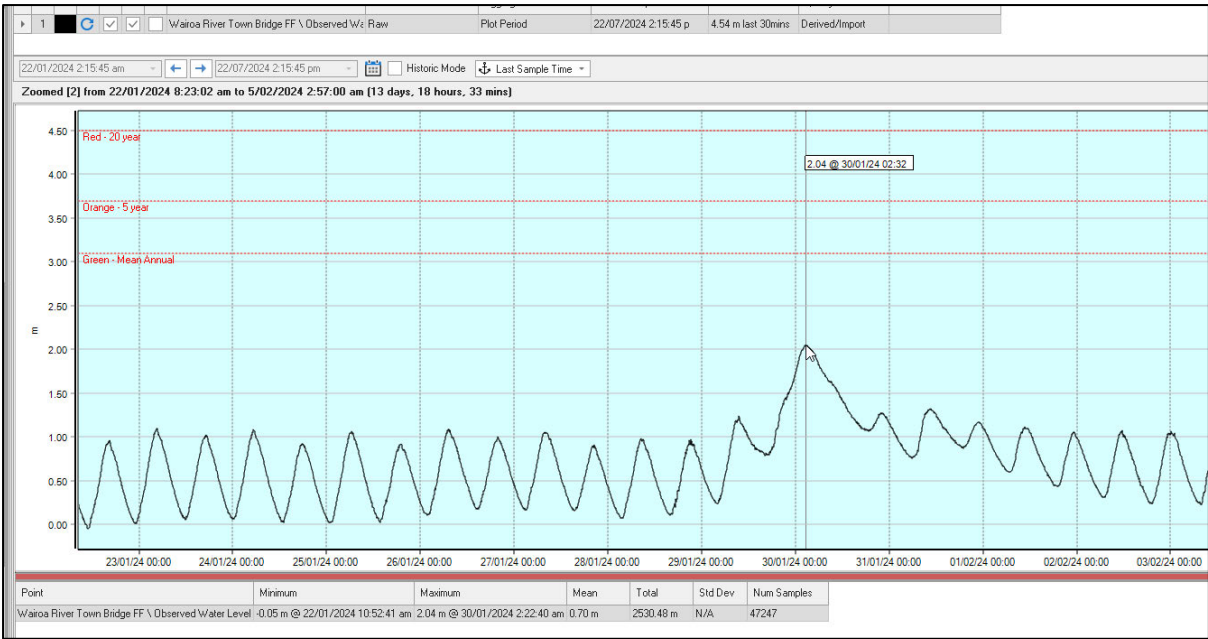
Water level at town bridge was up to elevation 2m (HB1962), (NZVD16 = 1.8 m), which is about 1 m below mean annual.

Peak level up to elevation 2 m at town bridge.
