## WAKA KOTAHI ARCHAEOLOGICAL SCREENING: WAIKARE GORGE REALIGNMENT

WAIKARE GORGE REALIGNMENT, JAN 2022

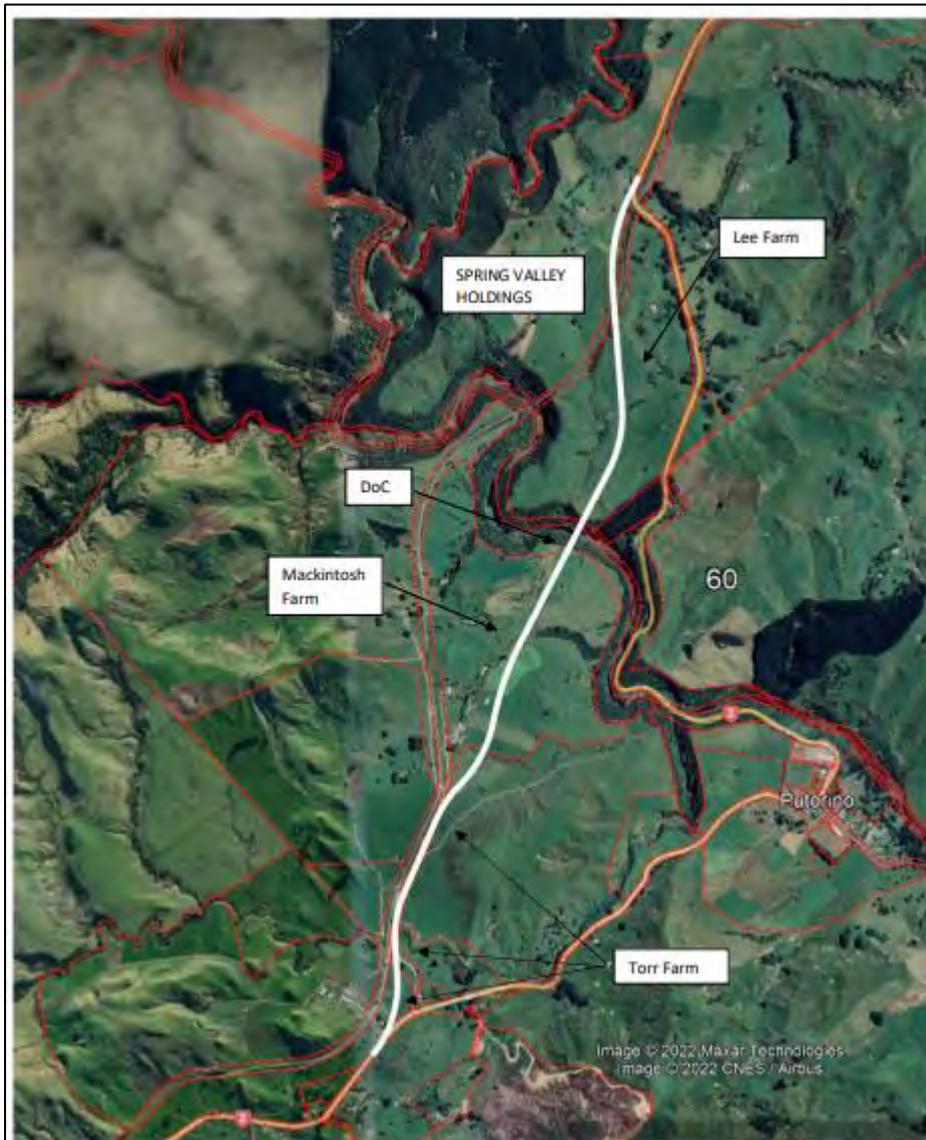
The 'white option' preferred alignment and affected properties assessed herein (Source: WSP).

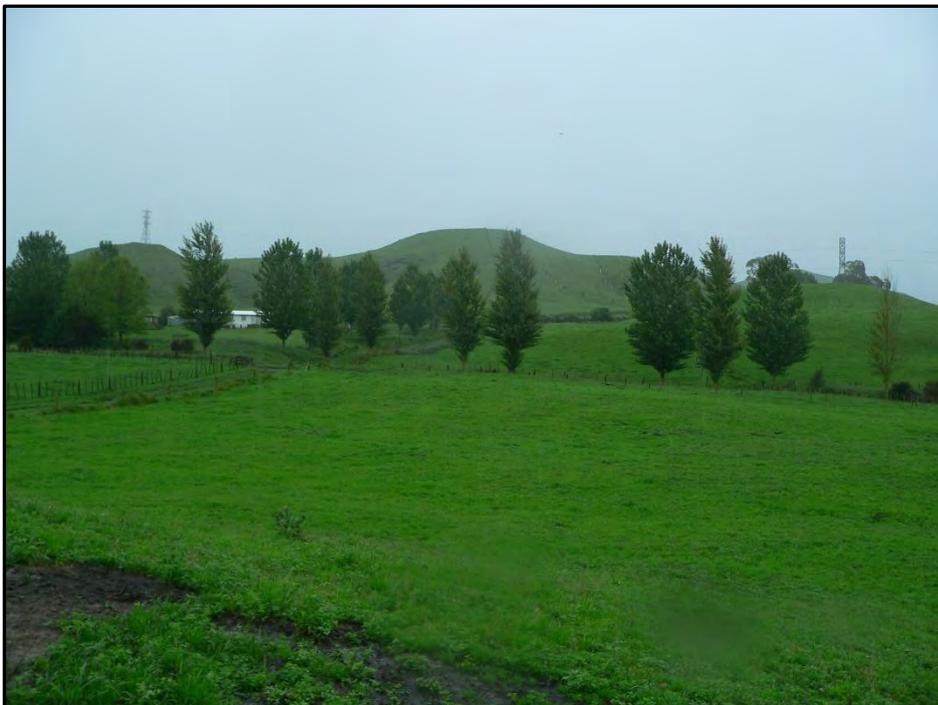
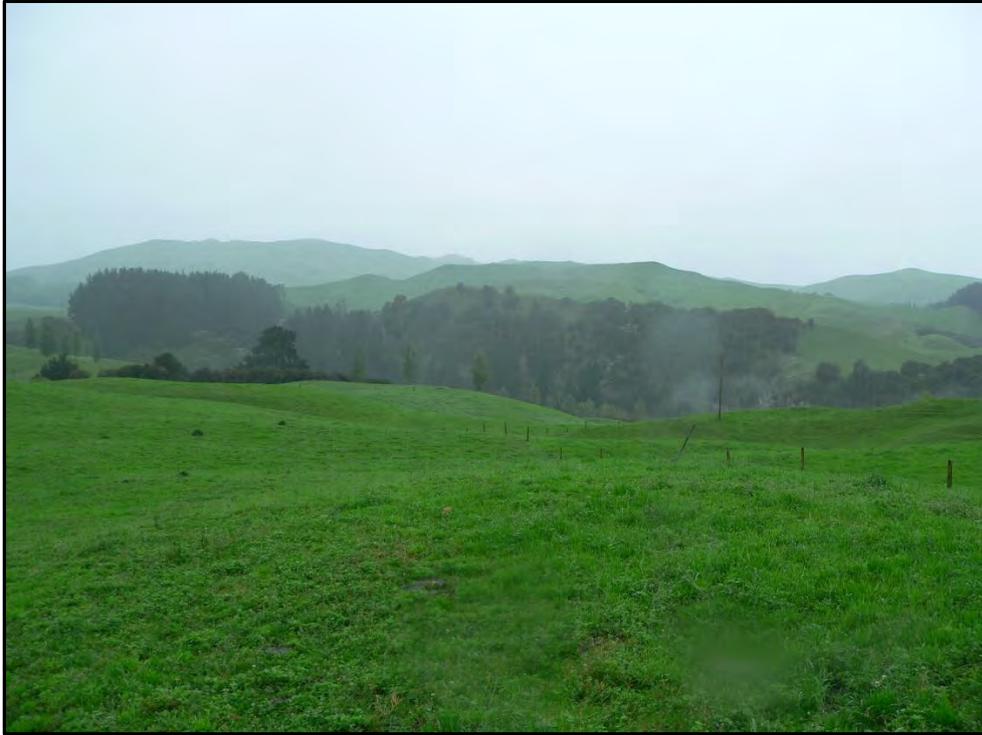
Aside from farm tracks, the occasional pond or other farm related activity, and possibly historic ploughing, there was very little apparent modification to the ground surface across much of the four properties. No archaeological indicators such as potential remnant pits or eroding hearth or midden type material was noted on any of the properties. Exposed track banks offered frequent opportunities to search for either material culture or feature profiles. It is assumed that much of this pasture has been plough cultivated, albeit rarely, in the past.

Although Mackintosh Farm and Lee Farm are immediately adjacent to the Waikare Gorge, making them ideal candidates for activity or occupation associated with the river, the drop to the water is very steep. Whilst there likely was and may still remain places where the river could have been accessed there are also much easier access points for resource harvesting along the river corridor. It seems more likely that activity associated with monitoring the river traffic was occurring in this area rather than directly accessing river resources.

### **Work could proceed cautiously under a robust Archaeological Discovery Protocol.**

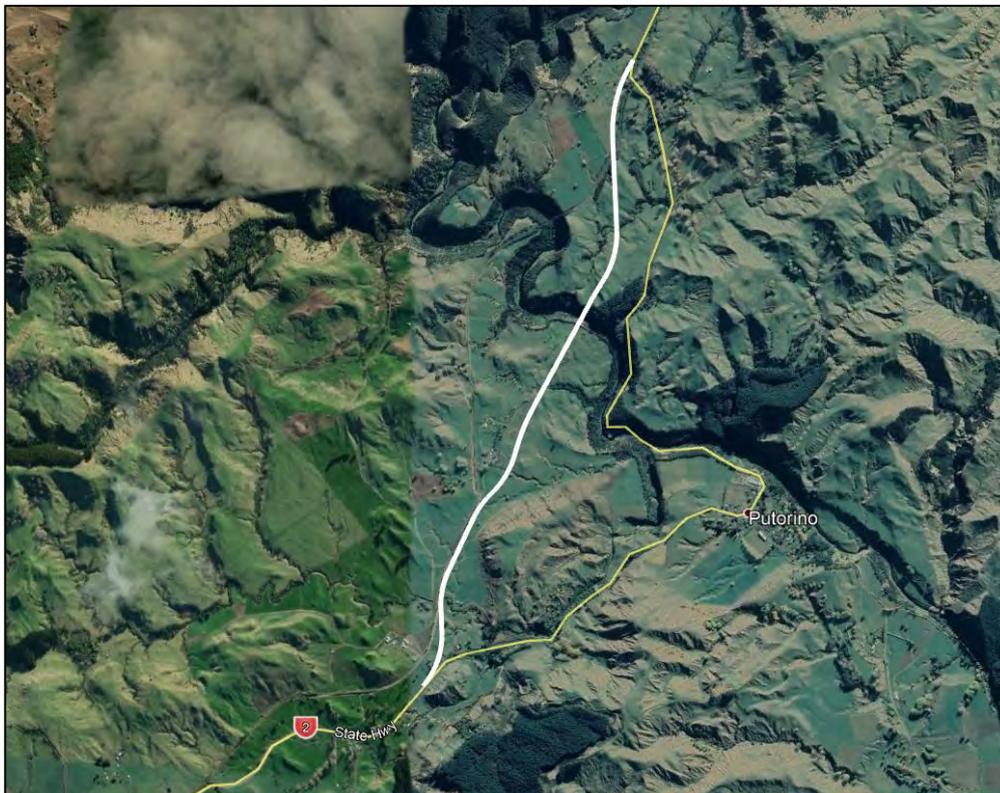
Figure 1: The proposed route of the realigned SH2 (white line). The present alignment is shown in yellow.

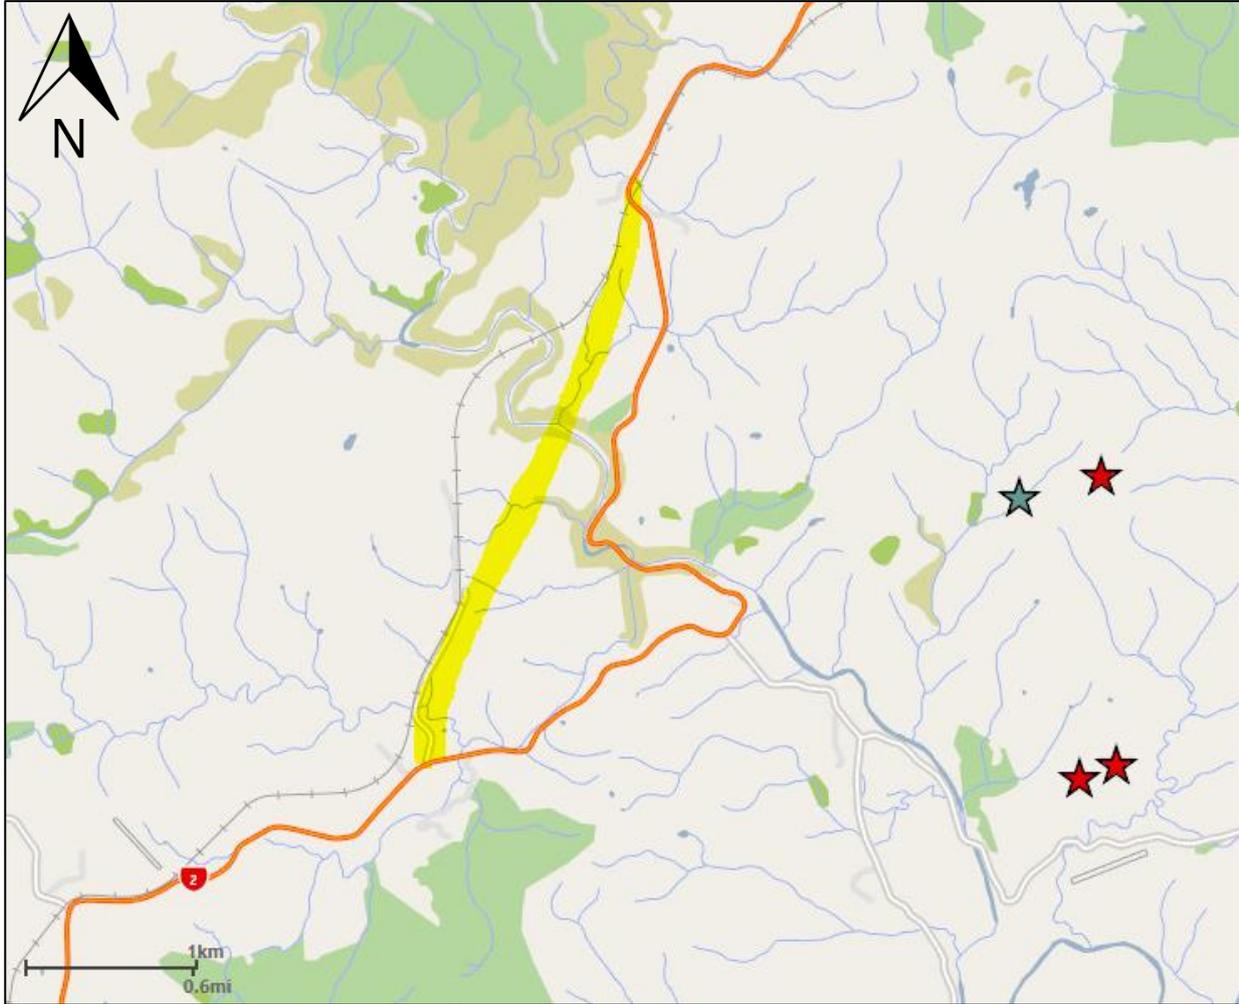
There are no archaeological site records situated on the proposed road alignment. The closest recorded sites are in the hills about 3km to the east of the project area (Figure 2). They include Pukepiripiri (W19/302), a large pa complex comprising several large raised-rim pits with drains, numerous other pits and terraces. The three other sites in this area are all pits, or groups of pits (W19/299, W19/300, W19/301). The presence of these site types indicate that the wider area and landscape was probably utilised for kumara horticulture.

Figure 2: Archaeological site records (stars) near the proposed works area (highlighted in yellow).

It is recommended that an Archaeological Assessment report is prepared by an archaeologist, including a thorough survey of the proposed route. This assessment report will determine whether there is a risk of archaeological sites being affected by the proposed works. If risk is identified then an Archaeological Authority will need to be applied for from Heritage New Zealand Pouhere Taonga.
