*Hawke's Bay State of the
Environment 2018 - 2021*

**Land & Water
Wairoa**

15. Wairoa/Northern Hawke's Bay catchments

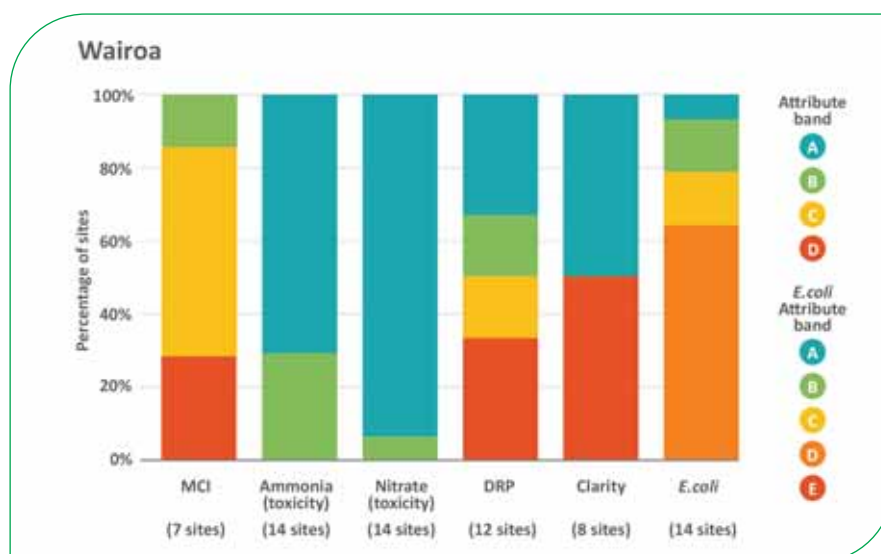
Figure 15-6. Bands (A = Good, D/E = Poor) in the National Policy Statement for Freshwater Management (NPS-FM) for river attributes in the Wairoa/Northern Hawke's Bay catchments. DRP = dissolved reactive phosphorus. MCI = macroinvertebrate community index. Grading based on latest five years of available data.

Figure 15-6 shows aspects of water quality that can help us determine the health of our rivers and streams. Excess nutrients can cause algal growth and deplete oxygen levels, whereas sediments can reduce light and habitat. Bacteria such as *E. coli* can make water unsuitable for swimming and contaminate shellfish.

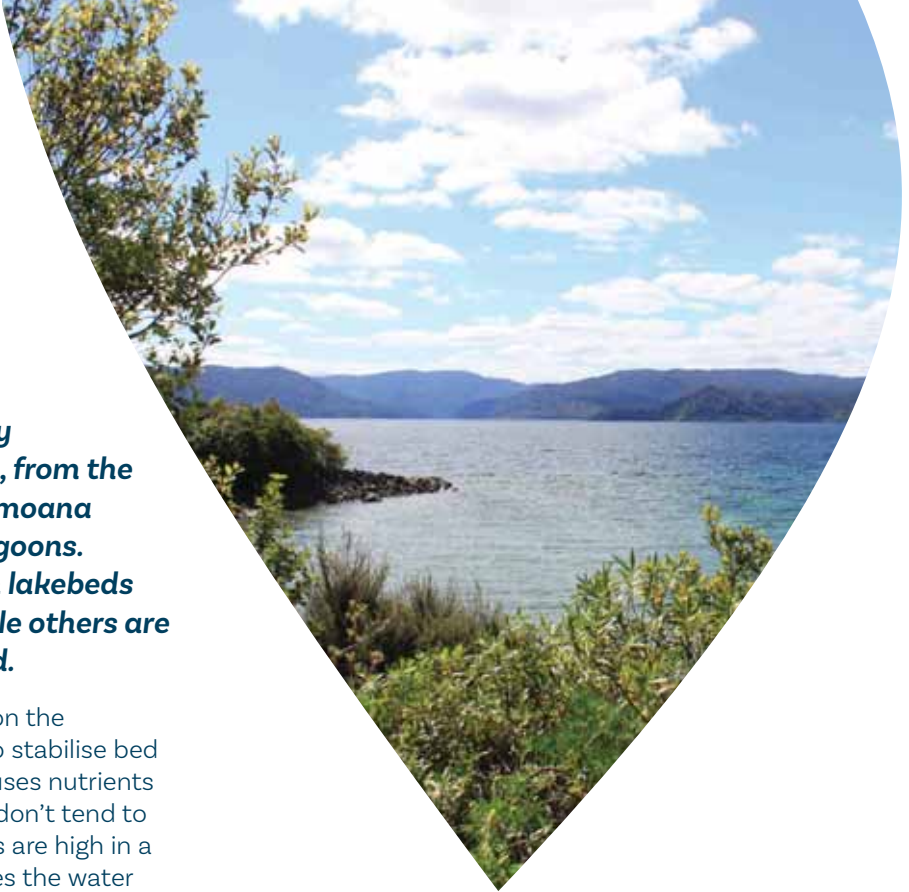
Figure 15-9. Different lake states depending on aquatic plants and algae. Symbols courtesy of the Integration and Application Network (ian.umces.edu/symbols/).

When nutrients are low in a lake, plants on the lakebed dominate and their roots help to stabilise bed sediments (Figure 15-9). The vegetation uses nutrients from the water to grow, so algal blooms don't tend to occur. On the other hand, when nutrients are high in a lake, algal blooms dominate, which makes the water cloudy and stops light from reaching the lakebed. As a result, plants struggle to grow on the lakebed, which keeps the lake murky.

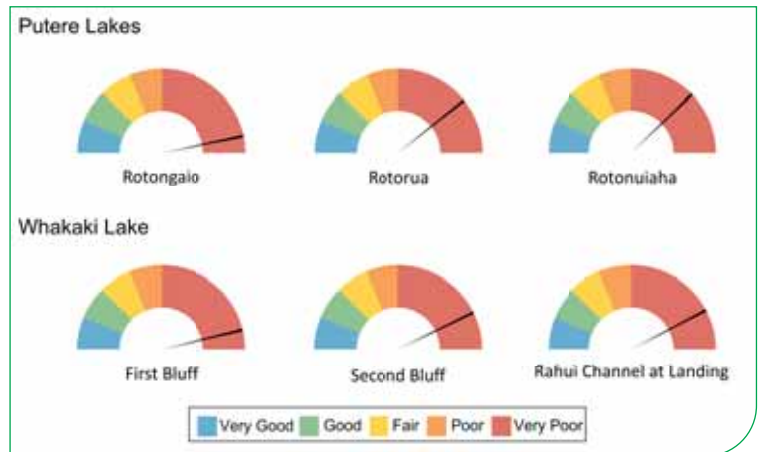
Figure 15-10. Trophic Lake Index (TLI) for Putere and Whakakī Lakes. The TLI score for a lake is calculated using four separate water quality measurements: total nitrogen, total phosphorus, water clarity, and chlorophyll-a.

In 2020, Ngāti Pahauwera coordinated a water sampling programme of these three lakes to help inform management options. NIWA surveys in 2016 had showed the invasive aquatic plant hornwort dominated Rotoroa and Rotonuiaha, but the kaitiaki water sampling showed water clarity in these two lakes is high and algal blooms are rare. In contrast, Rotongaio, which had no hornwort, has the worst water quality and frequent algal blooms. Even though the lakes appear quite different, water quality in all three lakes is rated “very poor” according to the trophic lake index (Figure 15-10).

HBRC has monitored water quality in Whakakī Lake for four years. These results indicate that the lake’s water quality is “very poor” according to the Trophic Lake Index (Figure 15-9). The lake is now dominated by algae, with persistent blooms of toxic cyanobacteria. Multiple lines of evidence suggest that the lake has ‘flipped’ to this algal-dominated state during the last 20 years.

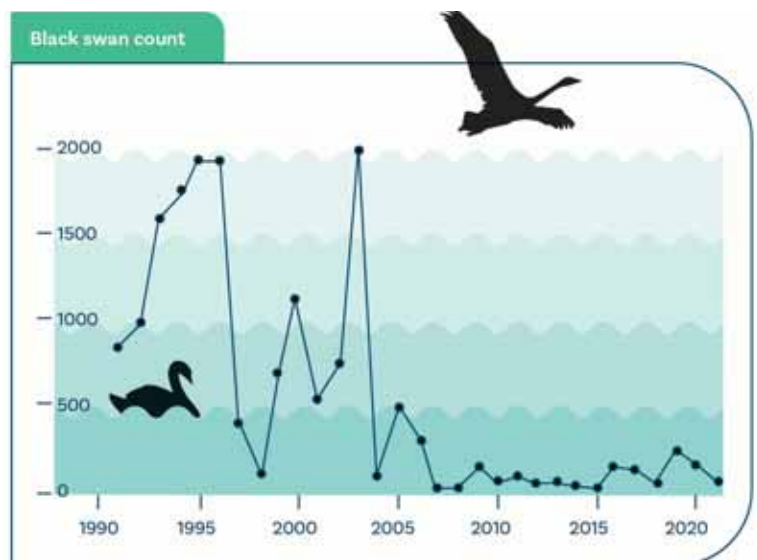
Figure 15-11. Black swan numbers at Whakakī Lake since 1991.

NIWA has monitored the vegetation in Whakakī since the early 1990s. The lake’s aquatic plant community was healthy in 1991/92, but the plants had drastically reduced by 2009 and largely disappeared by 2016. Black swan numbers also decreased over this time (Figure 15-11). Swans eat aquatic plants, so it is likely that worsening water quality over time reduced food and led to the swan decline here.

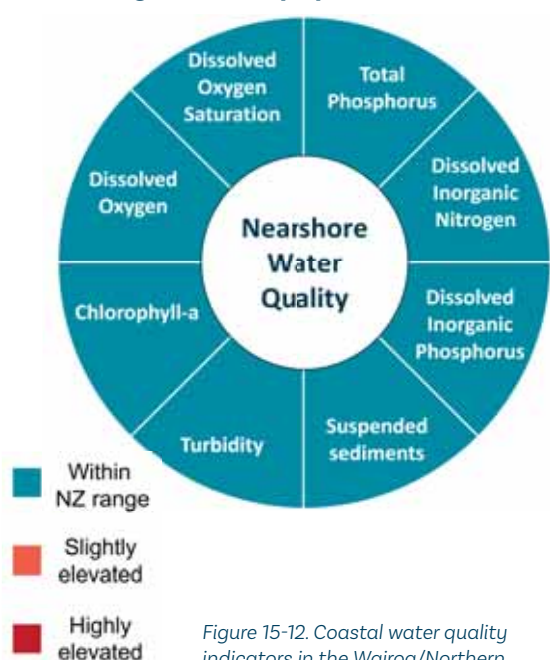
Figure 15-12. Coastal water quality indicators in the Wairoa/Northern Hawke’s Bay catchments, compared to other coastal sites in New Zealand.

Once released to the coast, the river and estuarine waters mix with open coastal waters, and any contaminants can affect the health of coastal waters. Fortunately, in this catchment, suspended sediment, turbidity, dissolved oxygen, chlorophyll-a levels, and phosphorus levels in coastal waters are within the ranges observed in other New Zealand open coast sites (Figure 15-12).

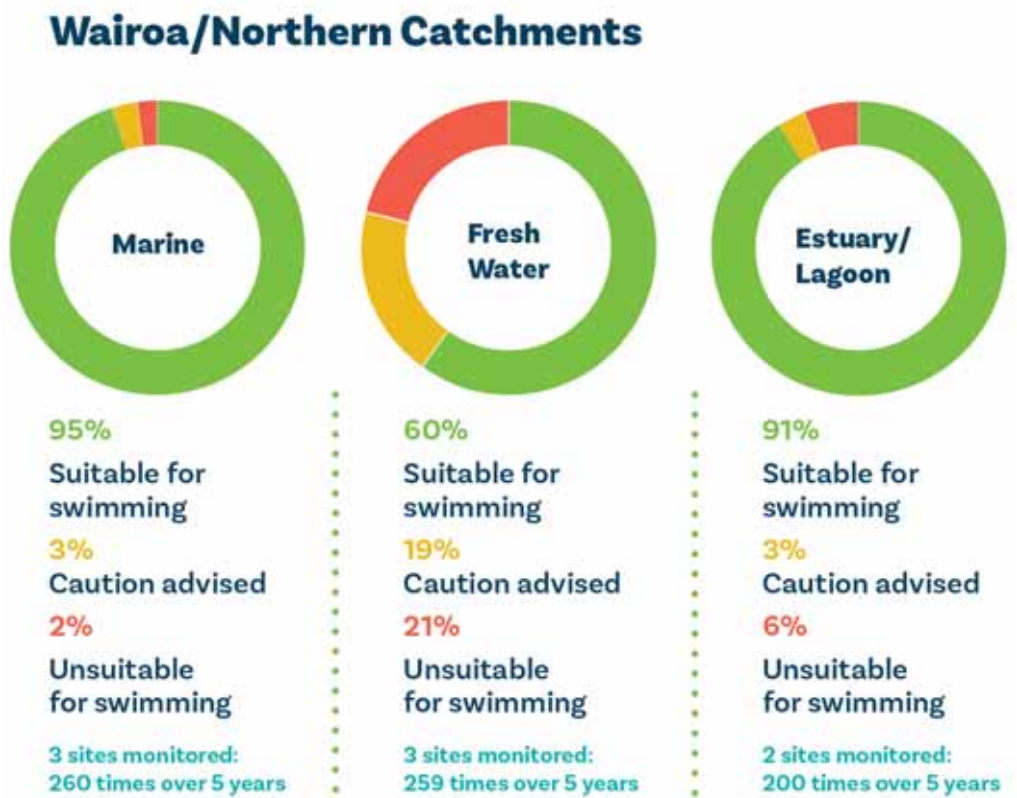
Figure 15-13. Swimming suitability of marine, estuarine, and freshwater sites in the Wairoa/Northern Hawke’s Bay catchments.

The Wairoa/Northern Hawke’s Bay catchments have many rivers and beaches that are popular swimming areas over the summer months. As is typical for the region, the northern coastal beaches tend to have excellent water quality and are almost always suitable for swimming (Figure 15-13). Mahia and Mahanga beaches were most suited for swimming, with only 2% and 3% of samples respectively indicating unsuitable swimming conditions.
