# Review of Physical Processes Influencing the 26 June Wairoa Flood

Data summary and analysis

Hawke's Bay Regional Council

Tonkin & Taylor Ltd

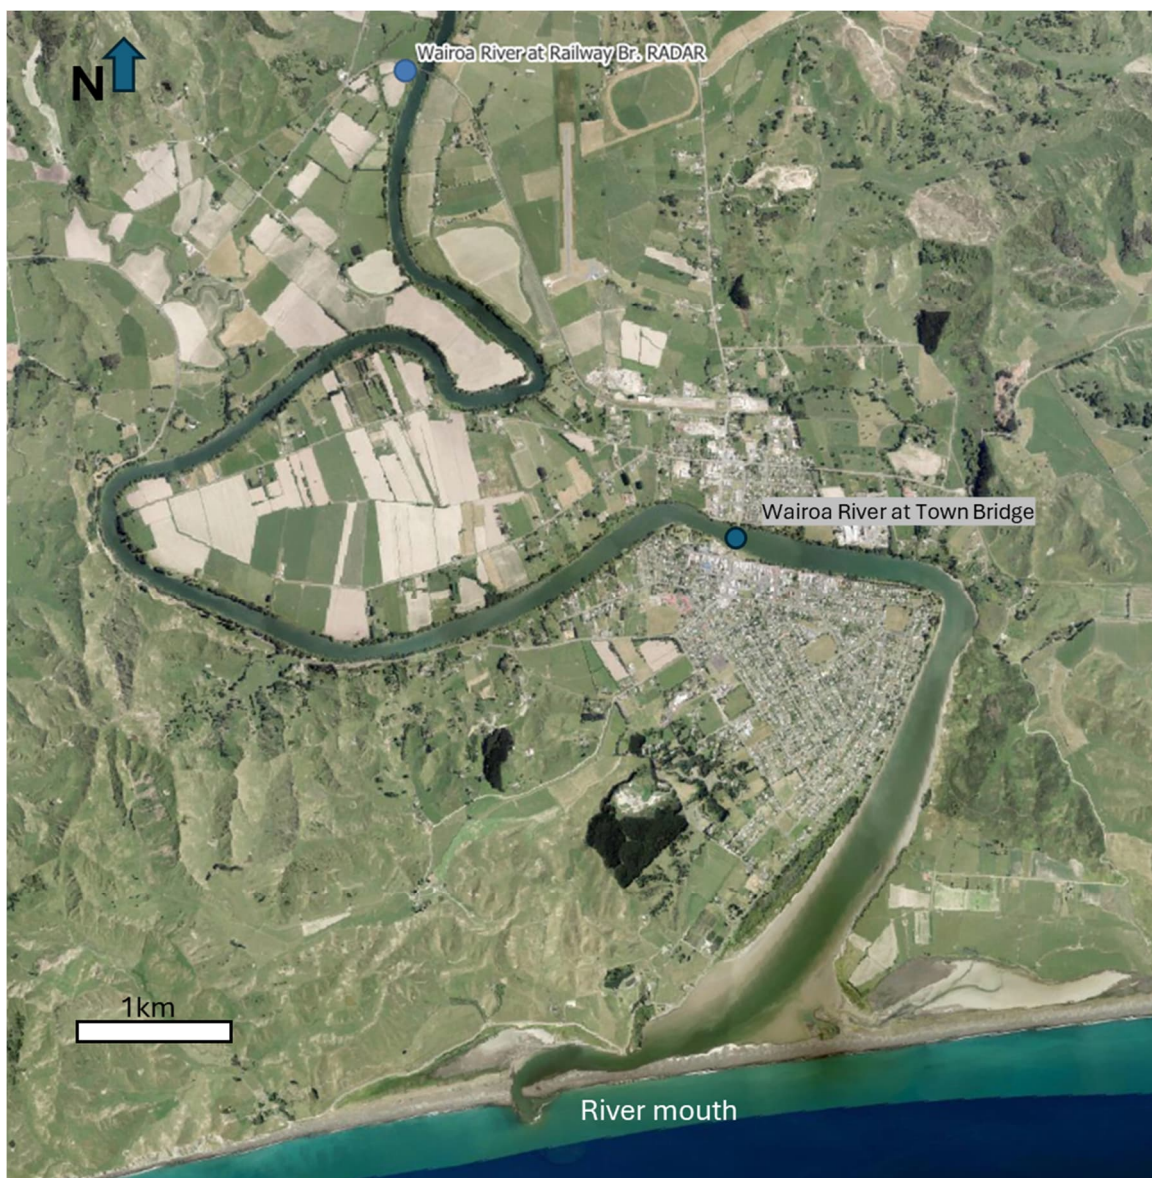
Figure 2.4: Location of River Level measurements on the lower Wairoa River. (Source: Aerial basemap from ESRI).

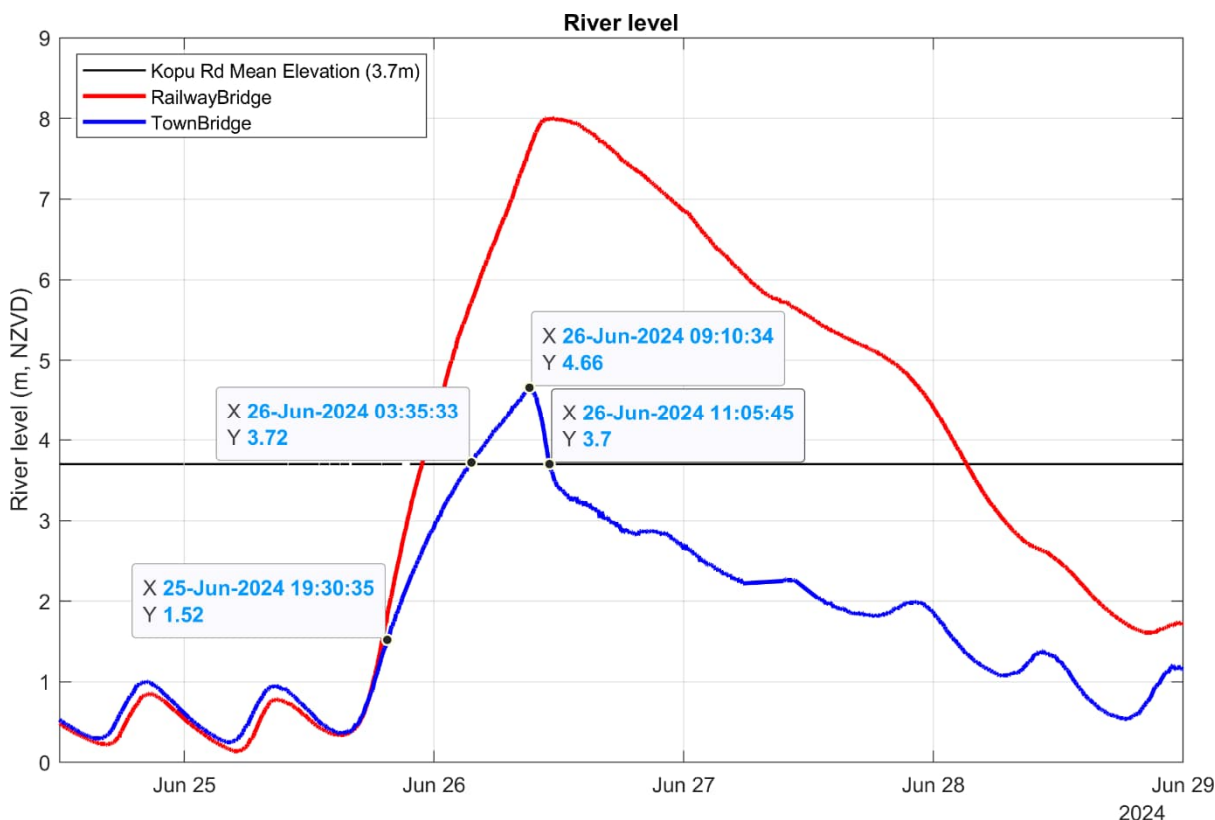
Figure 2.5: River level as measured at the Railway Bridge and at the Town Bridge, with the average elevation of Kopu road shown for reference. Data Source: HBRC.

Timeseries for the river level is shown below in Figure 2.5 and shows the river level started to rise above the typical tidal oscillation from 7:00 pm on Tuesday 25 June at both the Town Bridge and the Railway Bridge.

The river level at the Town Bridge exceeded the average level of Kopu Road for a total of 7.5 hours. River level continued to gradually decrease over the following two days, with a tidal signal evident from 28 June showing a return of more typical conditions.

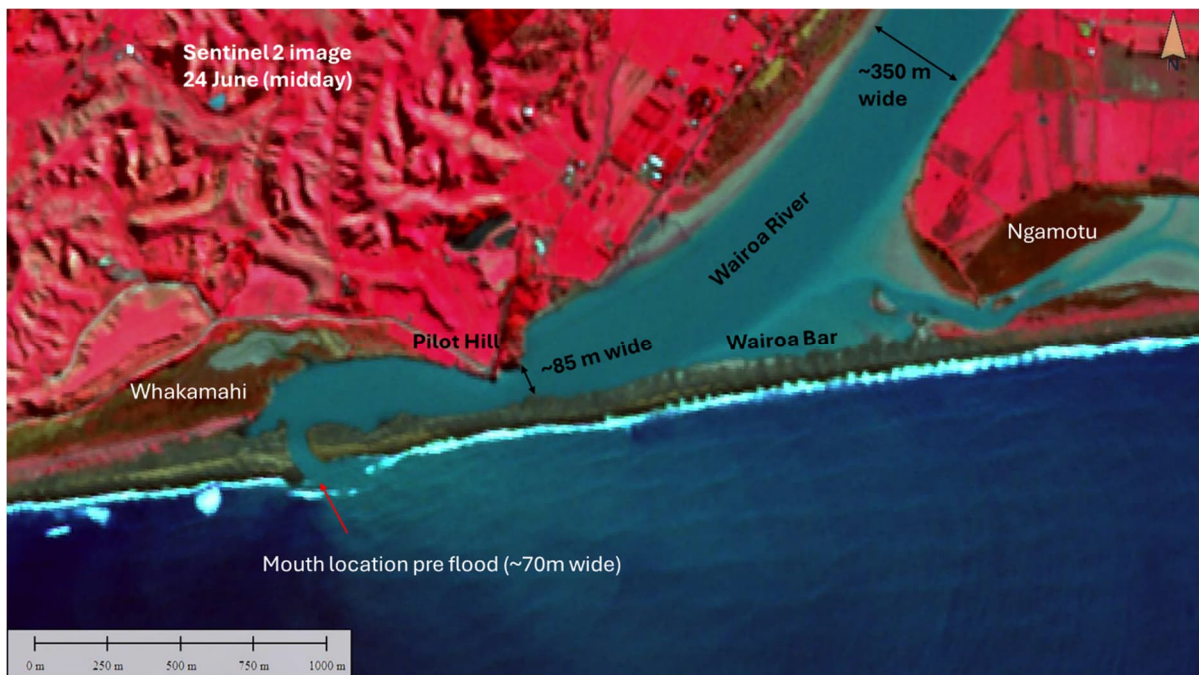
Figure 2.10: Annotated satellite image showing the bar position two days before the flooding event. Source: <https://browser.dataspace.copernicus.eu/>

A Sentinel 2 satellite<sup>16</sup> image captured at midday on 24 June 2024 shows the Wairoa Bar extending across the main river and west of Pilot Hill, with the mouth open at Whakamahi. The mouth was located approximately 780 m west of Pilot Hill, where a narrow constriction forms between the bar and the hill (channel is approximately 85 m wide). The river widens again after Pilot Hill, before exiting to the sea through an approximately 70 m wide mouth opening. For context, the main river channel along Kopu Road is approximately 350 m wide.

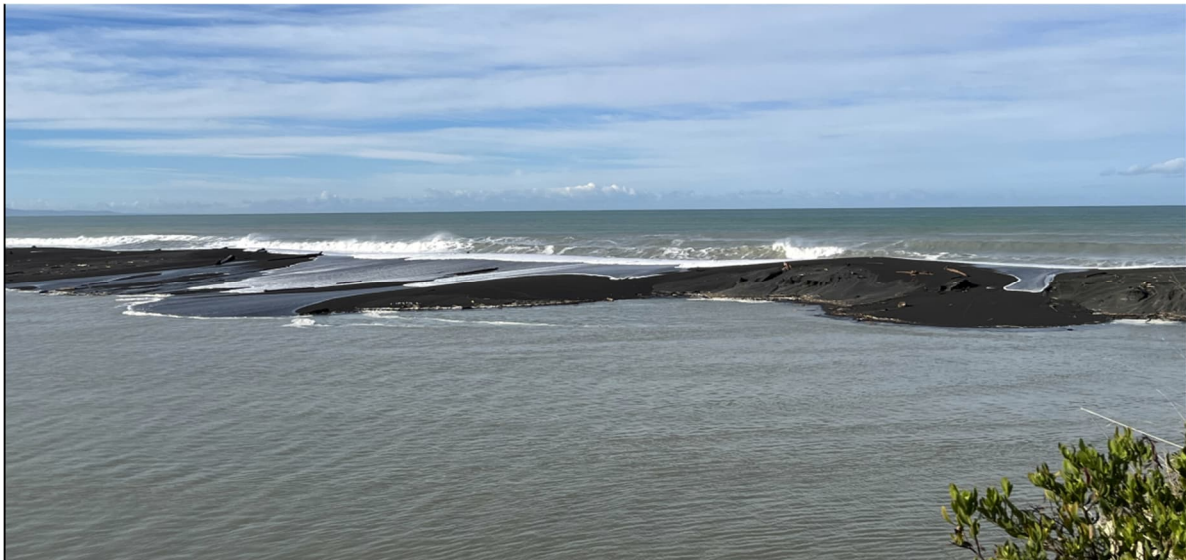
*Figure 3.3: Photo of waves washing over the bar at the breach location, taken from Pilot Hill on 28 May 2024.*

- The river flow is constricted at this point, causing a localised area of high velocity that causes the river level to back-up. The high velocity river flow at this construction point potentially assists scouring of the bar in this location to cause a breach.
- There are similarities between the last two breaching events. The breaching events in November 2023 and June 2024 both occurred at high tide (or just after) and were associated with spring tide conditions. Both breaching events occurred in the same location, aligned with Pilot Hill. It is possible that the bar crest level was lower in this location during the June 2024 event, as the section was still being re-shaped by waves following the November 2023 breach. Photos from Pilot Hill taken in May 2024 show waves overtopping this section of the bar, indicating a lower bar crest elevation at this location (Figure 3.3).

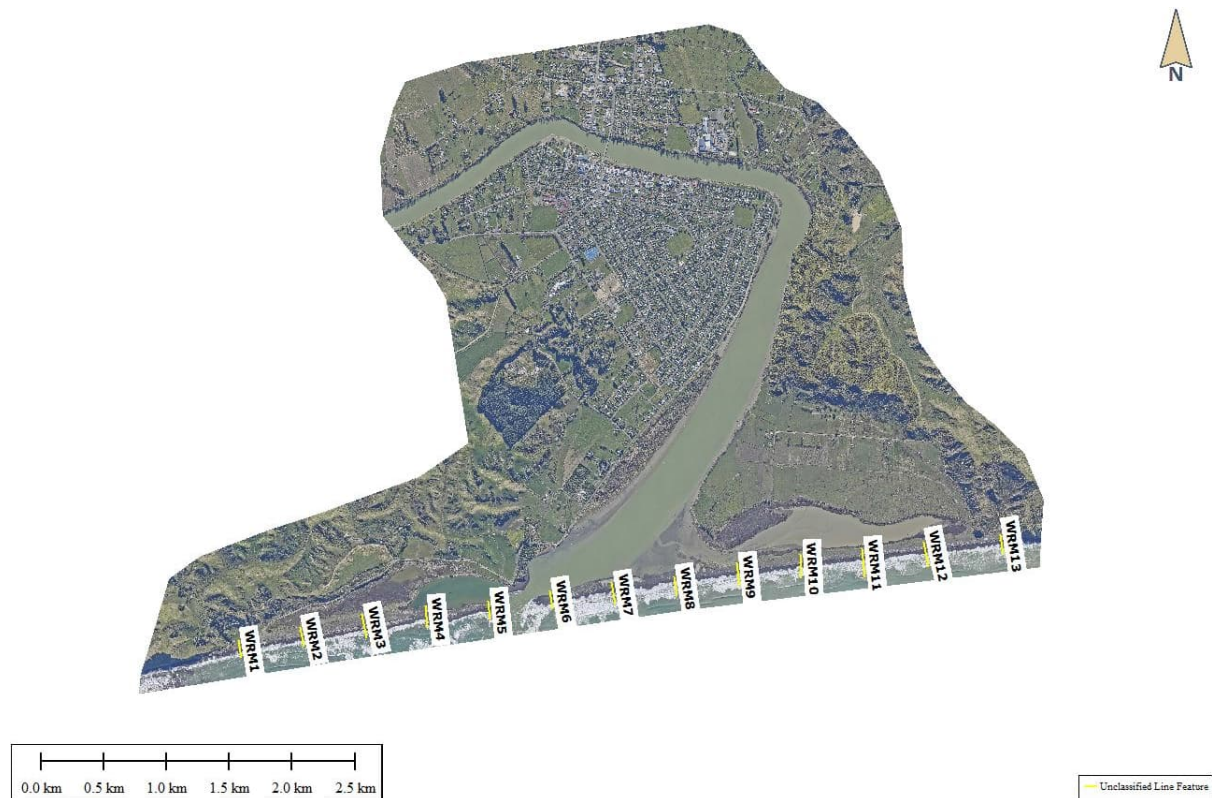
Figure 3.5: Beach profile locations along the Wairoa River Mouth (WRM).

Cross-sections were extracted in the same location as the historic surveys for the available LiDAR surveys and a consistent data analysis method was used to understand changes in profile position and elevation.

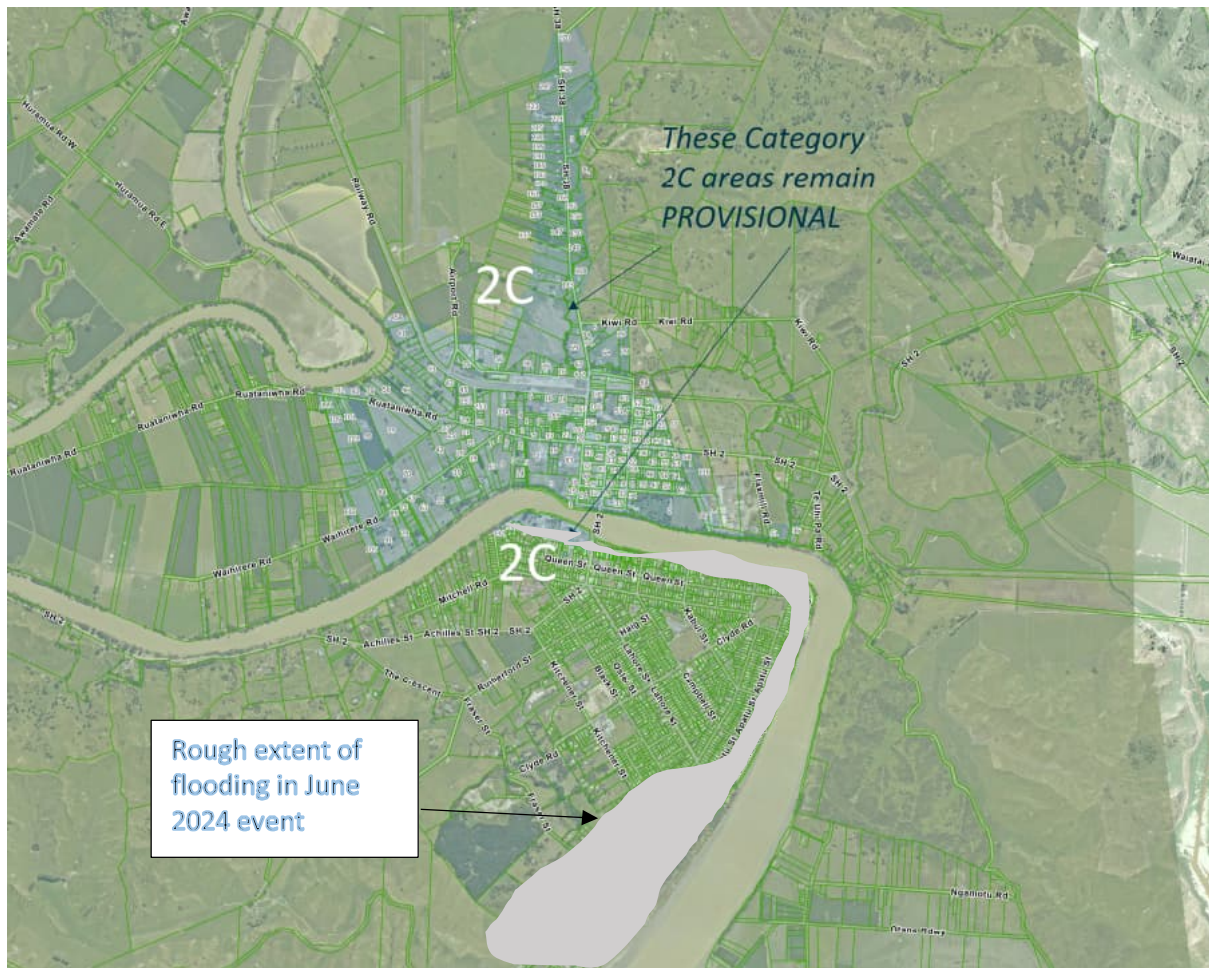
Figure 4.1: Category 2C areas assessed as part of the WSP modelling – not to scale.

WSP previously undertook hydraulic modelling using the TUFLOW model post Cyclone Gabrielle to assess flood mitigation options for the areas categorised as Category 2A, shown in Figure 4.1. Also shown in this figure is the extent of observed flooding in Wairoa from the June 2024 event.

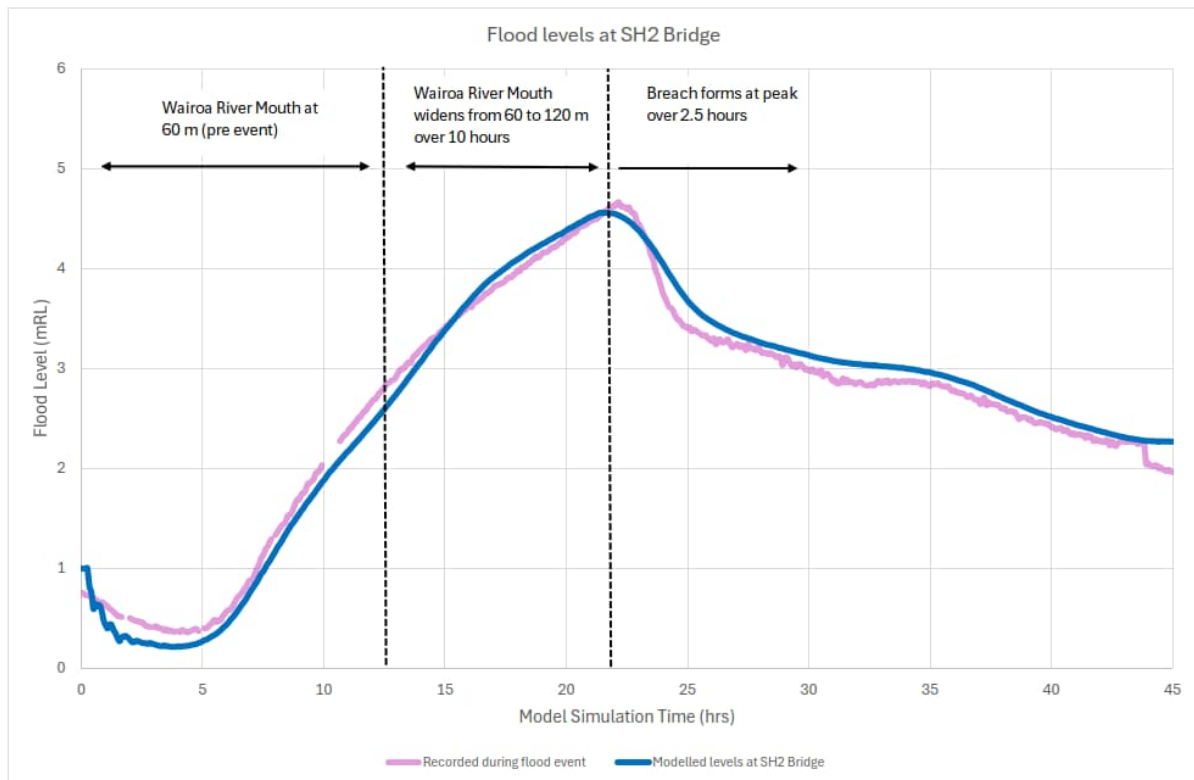
Figure 4.9: Measured and modelled flood level over event simulation.

The modelled versus observed levels at the SH2 bridge are shown in Figure 4.9. There are three key phases separated in this graph, where different mechanisms dictate the flood levels as outlined in the bullet points above.

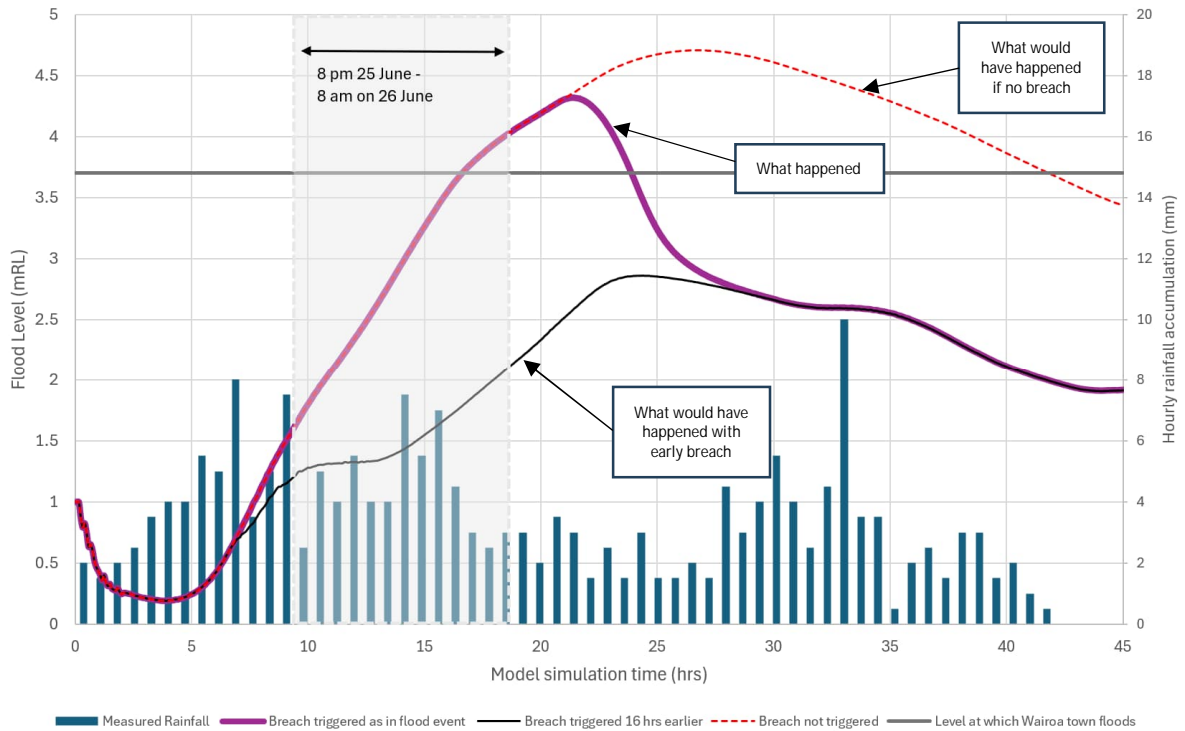
Figure 4.14: Flood levels with different breaches (grey line at 3.7 mRL indicates level at which flooding occurs), assuming no dynamic influence from waves.

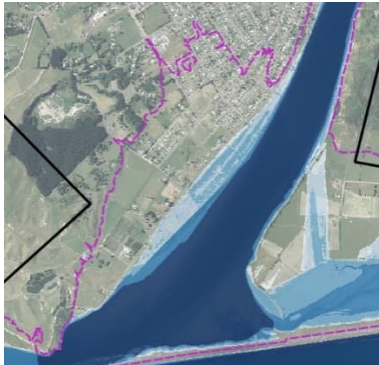
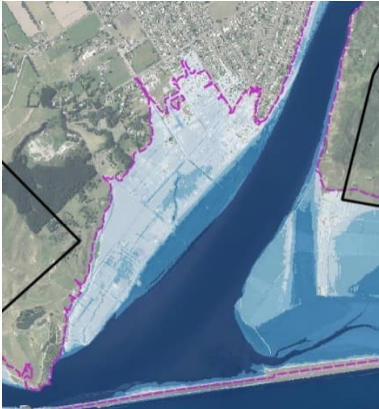
Table 4.1: Flood extents for the three different scenarios plotted on Figure 4.14

What could have happened with early natural breach	What happened	What could have happened if no natural breach
<p>June 24 Flood Extent (reference)</p>

Note that scenarios do not resolve the influence of waves.

The results of these simulations show an envelope of results that might be possible between two likely extremes – no breach and full breach. Time series water level plots (with water level at the Yacht Club being used as the reference) are shown in Figure 4.14 and the flood extents are shown in Table 4.1.

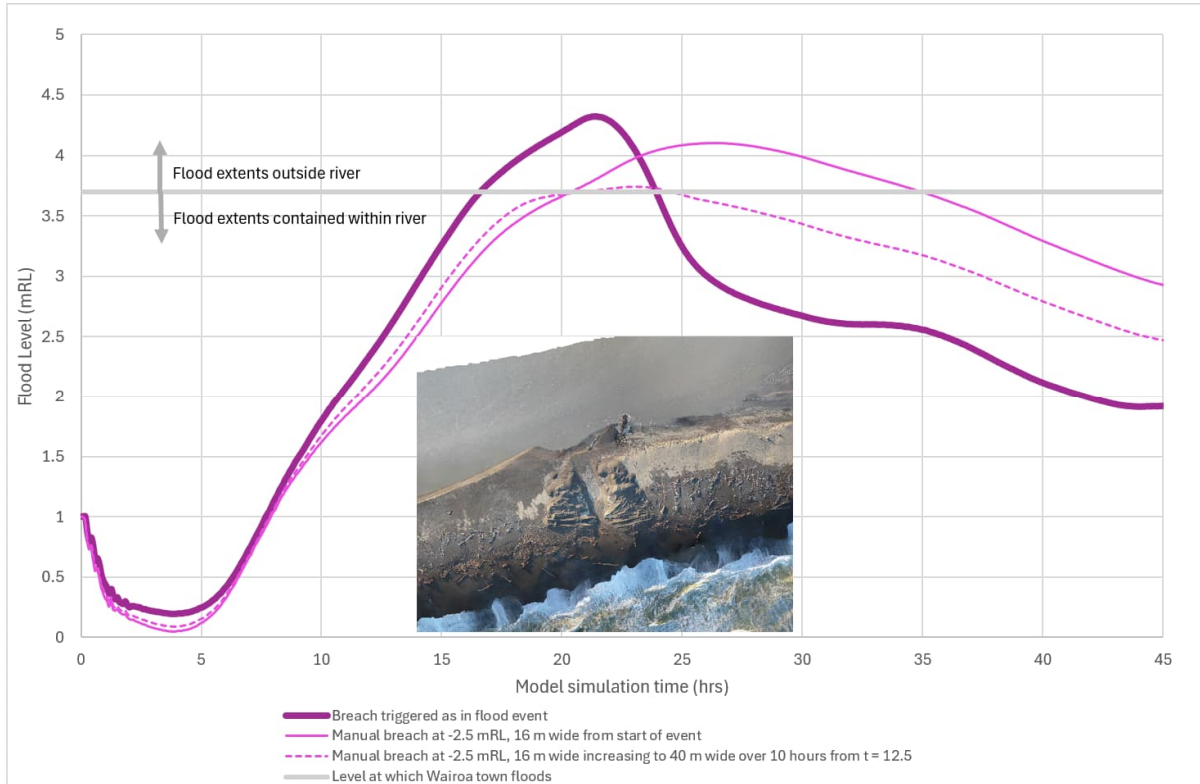
Figure 4.15: Flood level time series from manual breach compared against observed.

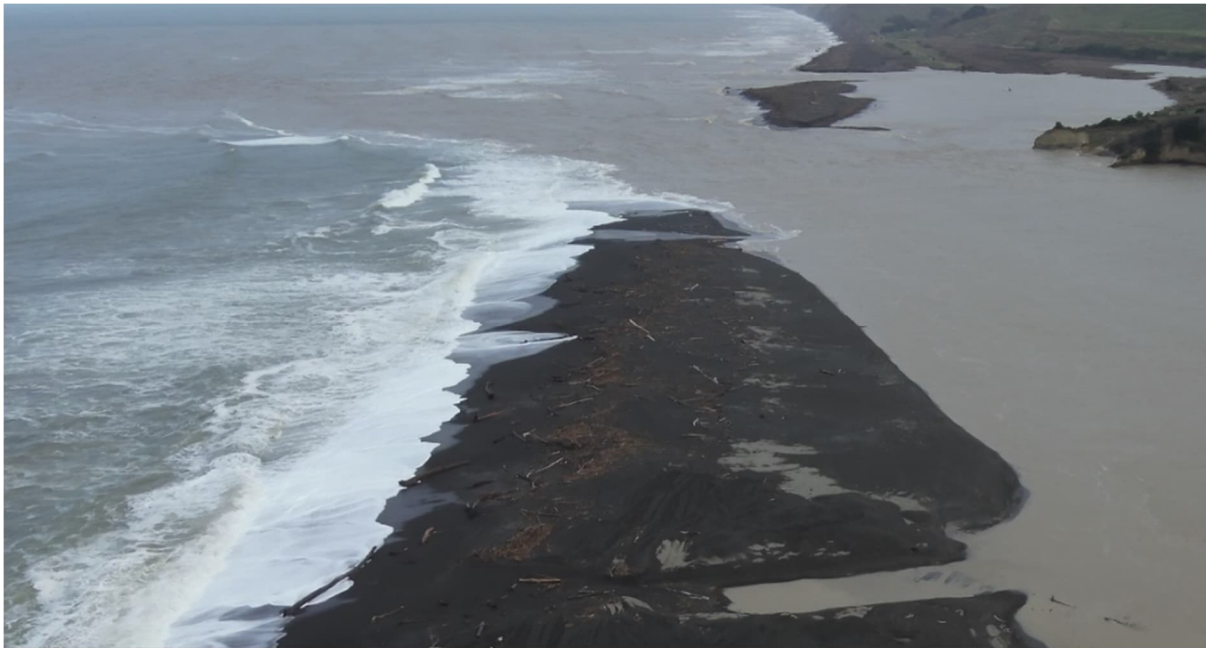
Figure 5.12: Snapshot from a UAV video provided by HBRC the day after the flood event showing an area of no surf-zone aligned with the outflowing.

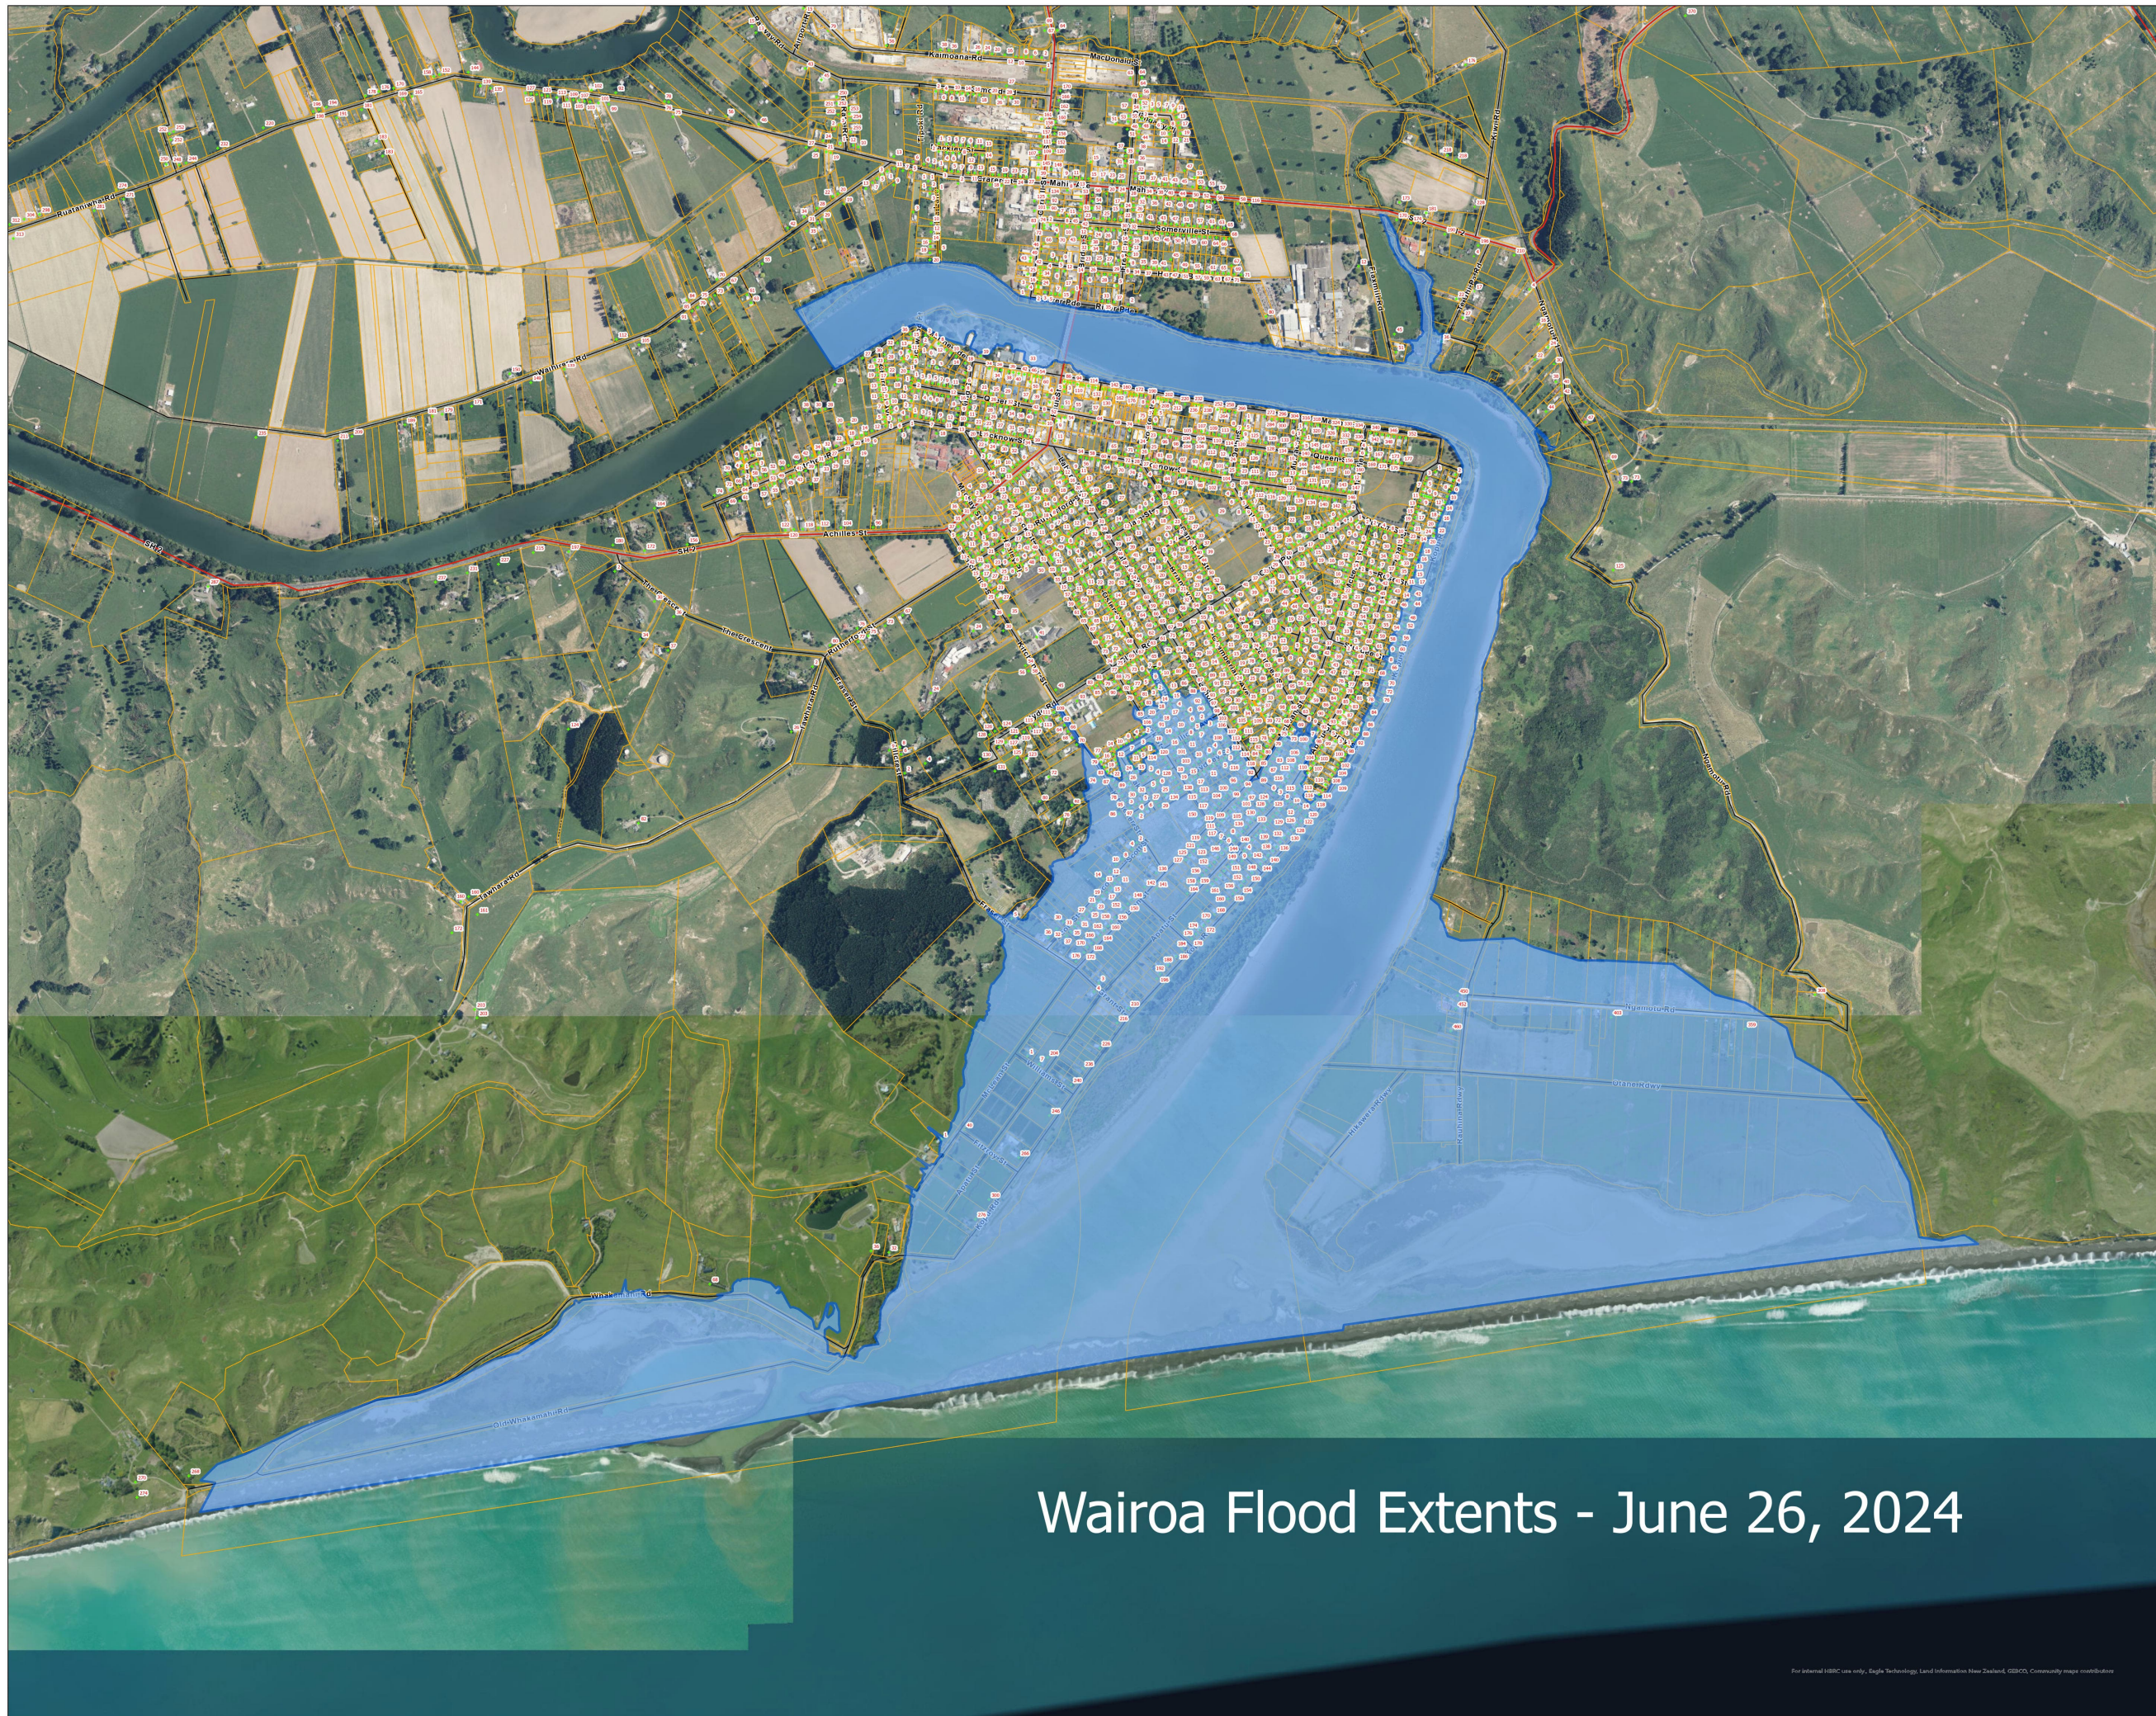
# Appendix A HBRC preliminary flood map

Note: Flood extents are indicative, and have been derived using aerial photos collected on June 28, 2024, photos sourced from various media, eye-witness accounts of flooding depths, contour information, and water level recordings from HBRC telemetry at the Town Bridge.

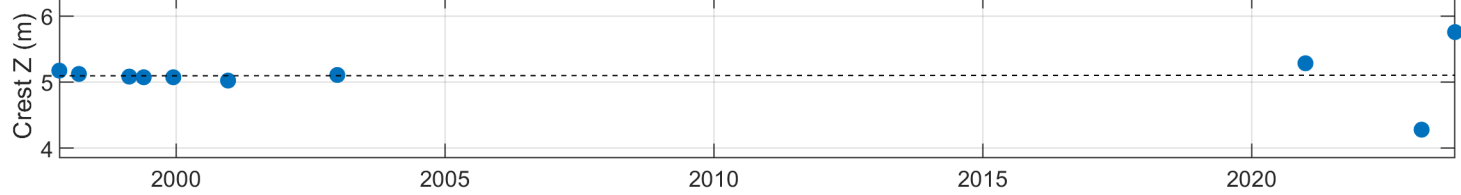
**Crest level: trend = 0.000386 m/yr**

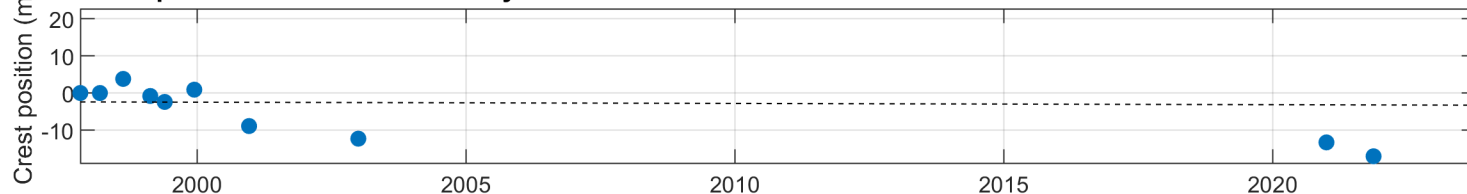
**Crest position: trend = -0.0338 m/yr**
