Assessment of space planted native trees species for soil conservation.

Prepared for Hawke's Bay Regional Council

Prepared by Peter Manson & Erica Whalley 04 July 2024

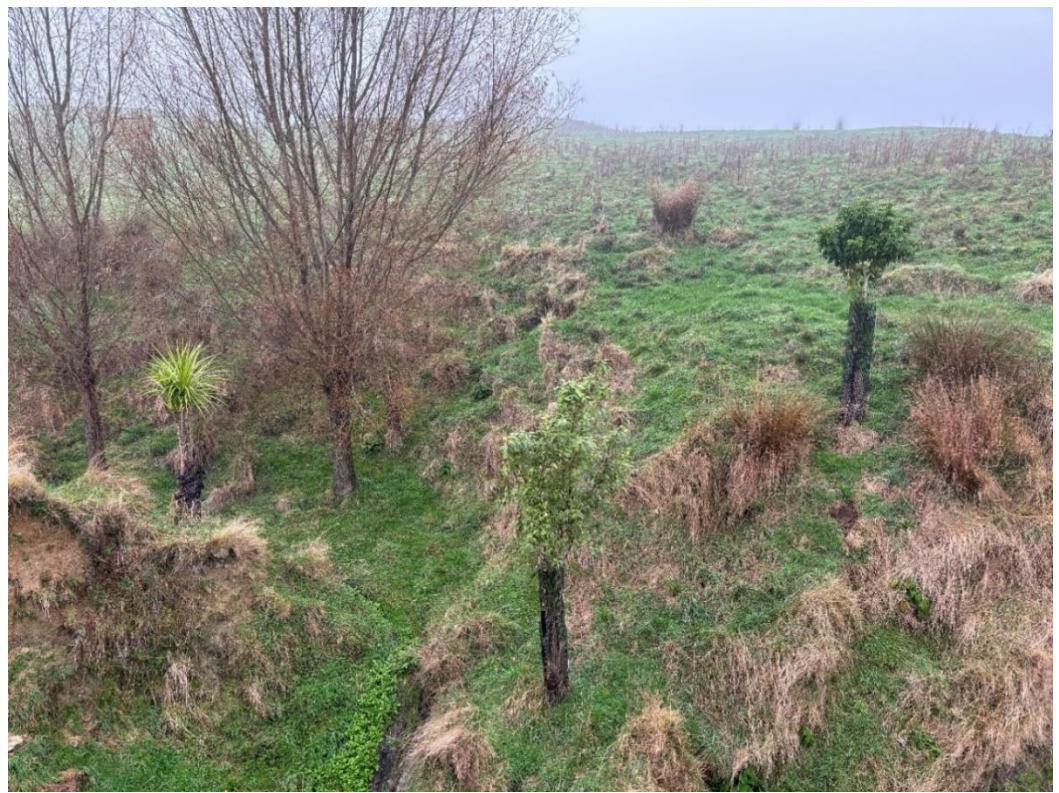
Figure 1: Hereheretau Top Yards Block. Native trees planted as a complement to the gully planted with willows.

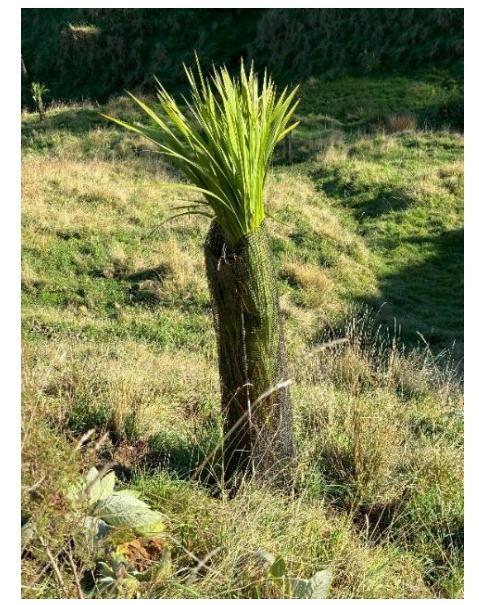
Figure 6: Cabbage tree on the Hereheretau Road site.

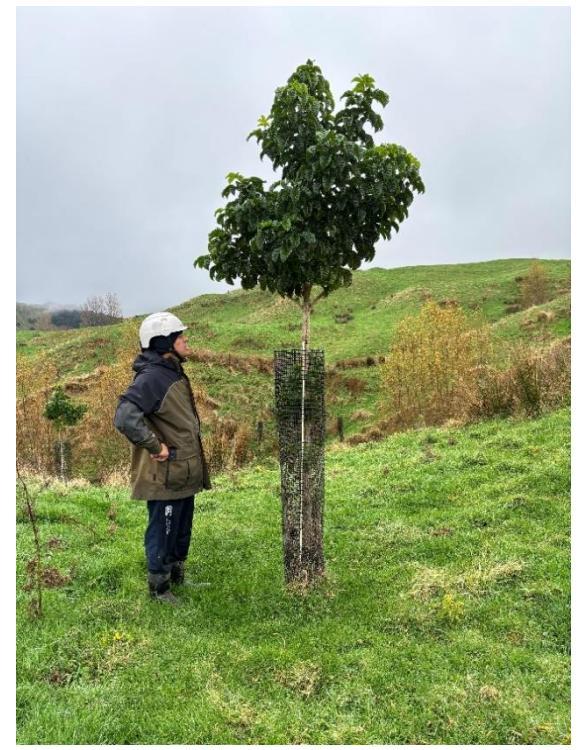
Survival and growth rate has been variable across all properties and sites. Some early observations of tree growth after the first two to three years showed that Puriri (Figure 7) and Pohutukawa were amongst the best performers. These were followed by Cabbage Tree and Kowhai. Rewarewa (Figure 8) was slow to start but has grown rapidly once established.

Figure 7: The largest Puriri seen on all sites. Puriri has been an unexpected performer generally (Hereheretau Station Top Yards).

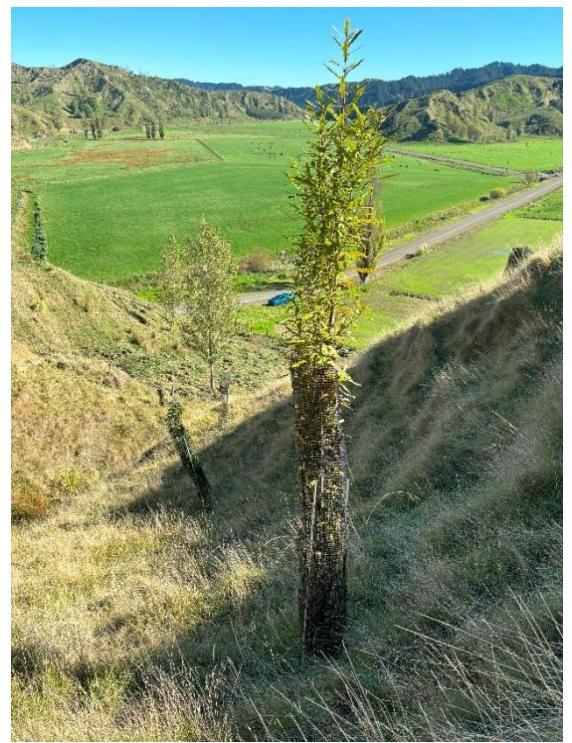
Figure 8: Rewarewa (Hereheretau Rd -Woolshed). Slow to start but 'ideal' form for space planting on pasture.

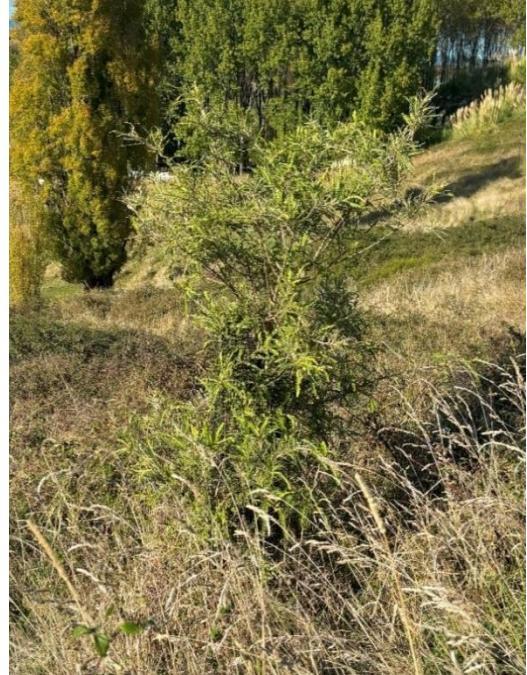
Browse at the top of the guard (Figures 13 - 16) once the tree seedling emerges, is an important but not urgent issue because the tree has reached a size that guarantees the extra investment to top up the structure and enable it to grow out of reach. However, left untended, the tree will never grow further, and it is likely that the guard and tree will be pushed over at some stage and the tree will be lost. Conversely, trees established on the two sites with almost no cattle pressure, appeared to grow fast in diameter as well as height, giving the impression that branch growth aided overall tree health and rate of establishment (Figures 17 & 18).

Figure 17: Kowhai with no cattle browse (Knauf property, Whakaki).

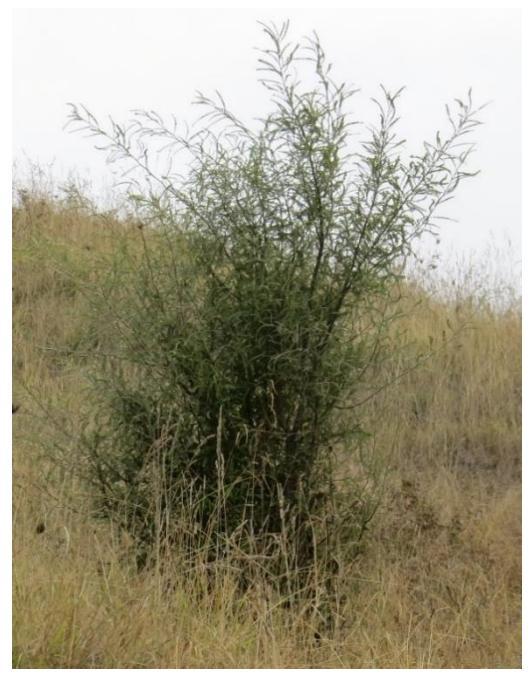
Figure 18: Kowhai with no cattle browse (Marae hill, Whakaki).

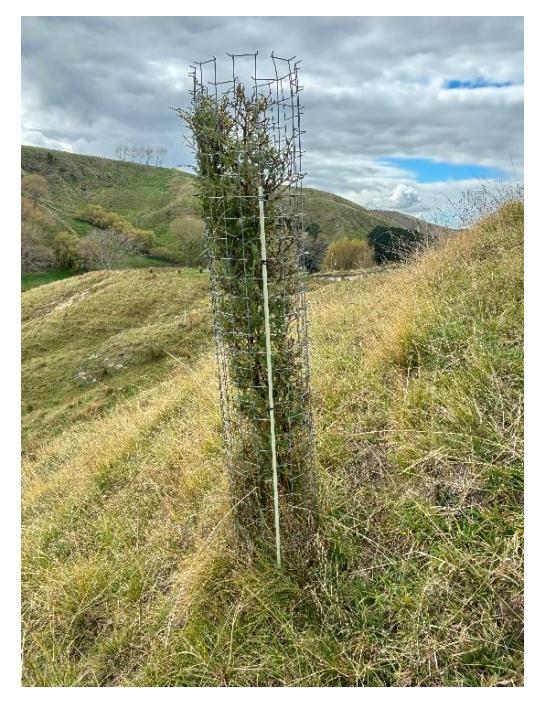
Figure 20: 'Cactus' tree guard. Reusable steel guard with spikes.

#### 2 Physical Tree Protector – re-usable (Figure 20)

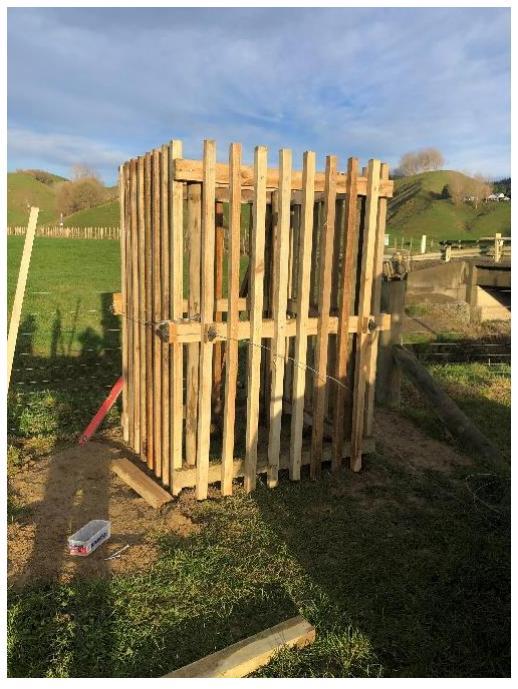
Figure 21: An extreme version of a permanent tree 'cage'.

#### 3 Physical Tree Protector – Permanent (Figure 21)

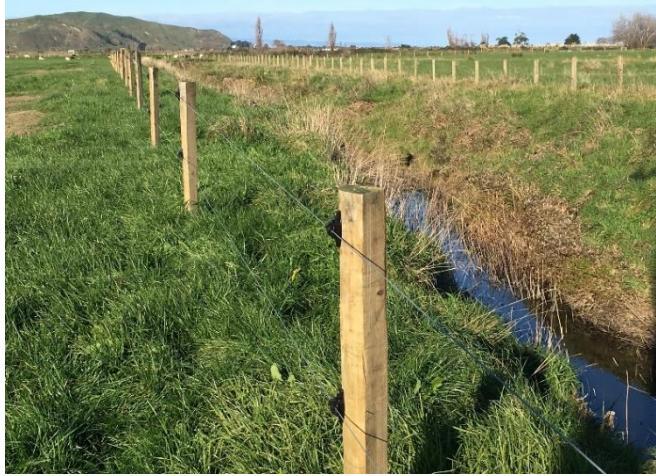
Figure 22: Two wire electric fence useful on hill country to manage cattle in tree planted areas.

### 4 Electric (Figure 22)

- Preferably use an electric 1-2 wire for pasture management and tree protection.

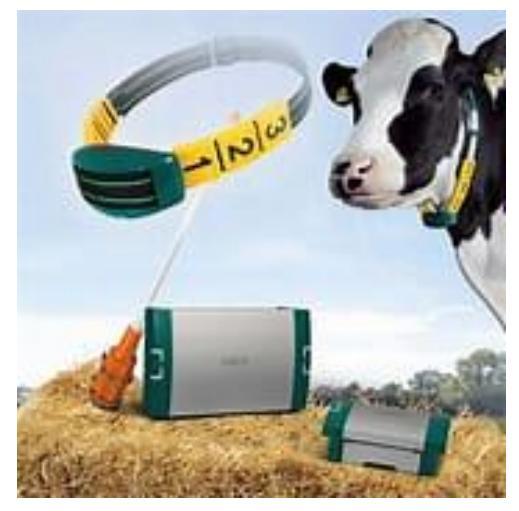
Figure 23: GPS 'Cow Collar' technology used for grazing may be suitable to prevent tree damage.

### 5 Electronic/GPS (Figure 23)
